## It's a New Tech 2 Look

Service Operations

# Cooling System Conditions on Vehicles Equipped with DEX-COOL™

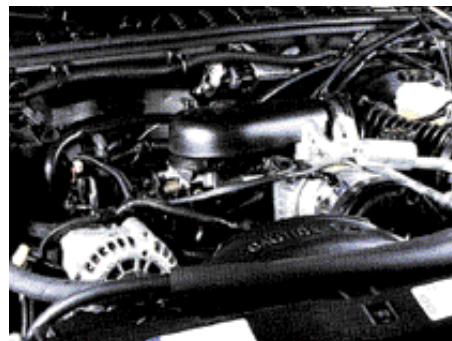
## S/T Truck Equipped with 4.3L V6

Bulletin 99-06-02-012B outlines the most effective repair for this model. The contaminant has been identified as iron oxide, and the cleaning material recommended in the bulletin was selected because it was proven to be the most effective at cleaning this type of contaminant. It is very important to follow the steps outlined in the bulletin precisely. Cases where the procedure was not effective have almost always been traced to substitution of another cleaning material or the procedure was not strictly adhered to. The most common mistakes have been:

1. Running the flush while the engine operating temperature is too low. Heat acts as a catalyst in this procedure, and if the temperature of the system is not maintained according to the bulletin specifications, the

cleaning will not be effective.

2. Failing to correctly assess the level of contaminants in the radiator before beginning.

NOTE: As stated in the bulletin, it's important to determine if coolant is able to flow through the third row down from the top of the radiator. If not, the radiator core must be replaced before the flush procedure. This is because the cleaner must be able to flow past the contamination in order to clean it. In cases where the system can't achieve sufficient flow around the contaminants, the cleaner cannot be effective.

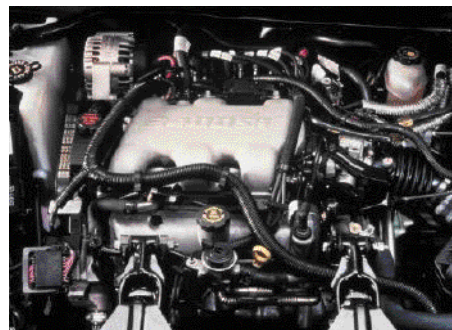
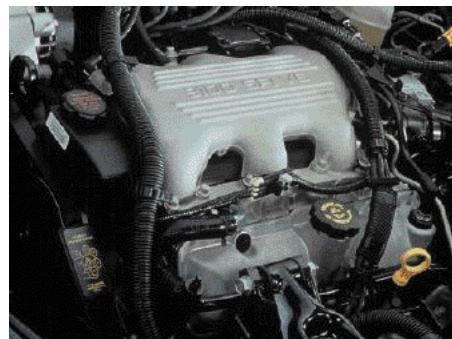
## W Car / U Van Equipped with 3.1L or 3.4L V6

Bulletin 00-06-02-004 describes the appropriate repair procedure for the issues most often seen on these models. Although similar in appearance to the S/T issue, the material on the radiator caps of these models contains no iron oxide. It is much more gelatin-like in texture and is usually comprised of sealer pellet residue, hose material and/or other contaminants. It is very rare to see cases where the contamination evidenced on these radiator caps has spread beyond

the radiator neck. If contamination is suspected beyond the radiator neck, you may choose to remove the radiator end tanks for further inspection.

Replacement of the radiator cap, wiping out the radiator neck and topping off the system is all that is normally recommended for these models. Unless other symptoms are present, it is not necessary to flush the cooling system or replace the coolant on these models before their published maintenance/change interval.

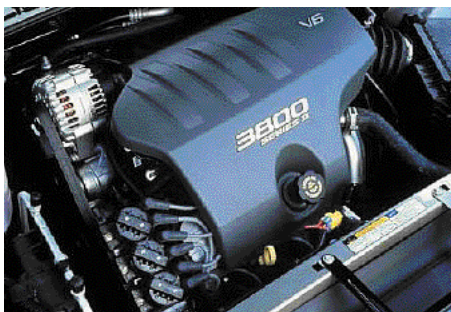
## 2000 LeSabre and Bonneville Equipped with 3.8L V6

Concerns on these models typically center around what is perceived as discolored coolant (usually dark and rust colored in appearance) and a ring of contamination around the inside of the coolant recovery bottle. Analysis has determined that both of these consist of excess sealer pellet material that was inadvertently installed at the assembly plant. Sealer pellet installation has since been discontinued on these models. Cleaning the coolant recovery bottle, topping up the system and checking the cap for proper function is all that is required on these models.

Finally, as stated in bulletin 99-06-02-012B, the radiator cap is not a good indicator of the general condition of the cooling

system. Typically the underside of the radiator cap will exhibit a greater amount of contamination than the rest of the system, due to the "beach" effect described earlier. Likewise, the color of the coolant is also not a good indicator of its general condition.
