## Electronically Controlled Viscous Cooling Fan

### Techline News

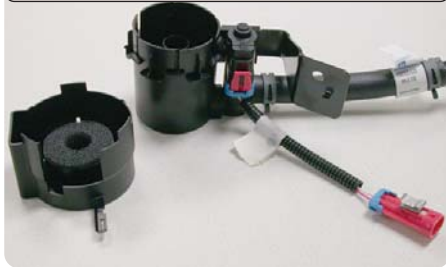
EVAP Vent Hose Assembly with filter

Some 1999-2002 Chevrolet and GMC C/K Pickup models may display a DTC P0446. A restricted or blocked EVAP vent path may occur when a vehicle is operated in a dusty environment, such as farming or mining.

A service procedure and replacement part has been developed to address this condition. A bulletin is pending. In the meantime, here are the highlights.

First, perform the diagnostics for P0446 to confirm the cause of the condition. Then replace the EVAP canister vent hose with p/n 15086426. This assembly has enhanced filtering and a removable, cleanable filter element.

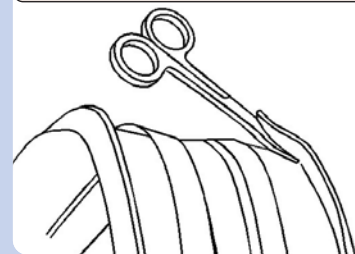
Cutting a relief notch

Owners of some 1999-2002 Chevrolet Trackers may comment that when the front windows are raised, they become slow, or bind, or tip forward in the track.

The cause is increased friction in the front window run channel due to a pinch point in the rubber. GM Service Bulletin 02-08-64-004 has just been released to communicate a field fix to relieve the pinch point by cutting a relief notch in the rubber run channel.

In cases where the forward area of rubber run channel is worn, replace the rubber channel with a new part. A new notched rubber run channel was released into Tracker production in March, 2002, and will soon be released as a GM service part. Until the notched service part becomes available, it is a simple procedure to cut a relief notch in the new part according to the instructions in the service bulletin.

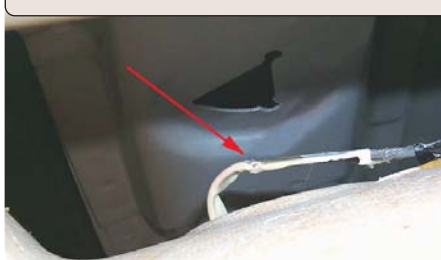
Headliner Removed to Show Wire Location

Owners of some 2000-02 Oldsmobile Intrigues may experience a number of inoperative components: interior lights stay on or inoperative, or Inadvertent Power Fuse blown causing inoperative cruise control, entertainment system, power windows, power sunroof and others. Codes B1477, B1482 and B2617 may also be set. Refer to bulletin 01-08-42-007 for details.

These conditions may be caused by a short to ground or open in the wires to the sunshade vanity mirror lamps, circuit 1732. These wires may become chafed underneath the headliner. If the Inadvertent Power Fuse has blown, incorrect diagnosis may lead to the unnecessary replacement of the BCM. When removing the sunshade, be very careful not to damage the bezel on the shaft, which is not serviceable separately.
