# New Levels of Precision in Wheel Alignment

### Techline News

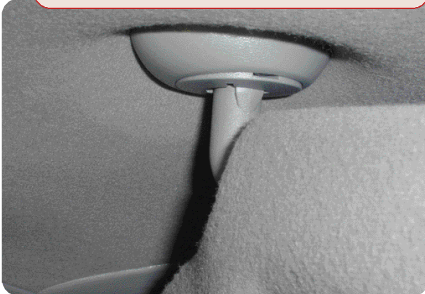
If you use the incorrect removal procedure or the incorrect tools, you will break the visor or cause cosmetic damage to the plastic parts.

**Pivot slot aligned with visor slot**

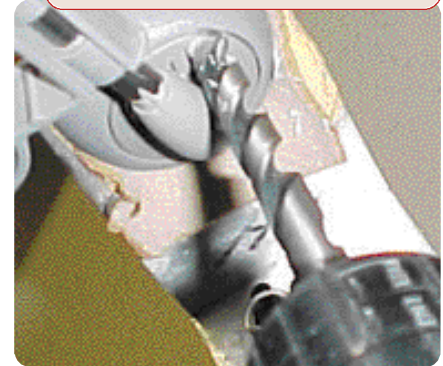
**Emergency removal using 3/8-inch drill**

If the recommended removal does not work, it will be necessary to destroy the visor pivot.

Use a 3/8-inch drill bit to drill out the pivot as shown in the photo. This will destroy the triangular lock in the bezel. Then, rotate the visor toward the side window to remove the pivot from the

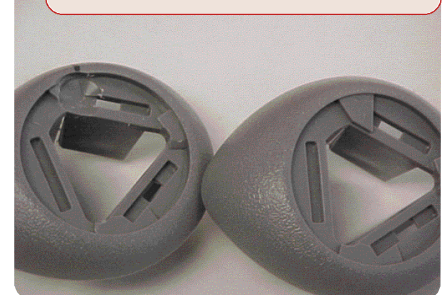
**Bezel on left showing drilled out triangular lock**

Obtain a replacement visor and bezel and install.

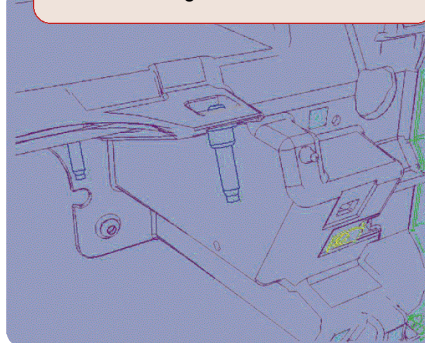
Steering column fastener installed in mag beam

But when you loosen the steering column fasteners, DO NOT simply loosen the retaining nuts. In many cases, the nut and stud come out as a unit, leaving the square nut stranded in the depression on the top side of the mag

beam. Then, when you attempt to install the stud, the square nut will be pushed out of position. It may then be necessary to loosen and move the instrument panel to gain access to the square nuts.

Here's the proper method for loosening the nuts. First, install a 13 mm crowfoot wrench to the nut. Then, install a number 7 inverted Torx socket to the bottom of the stud. Use the Torx socket to hold the stud while you loosen the nut with the crowfoot wrench. This prevents the stud from unscrewing from the square nut. Now, when you lower the steering column, the stud and square nut remain in position on the magnesium beam.

When you install the steering column, torque the retaining nuts to 27 N.m (20 lb ft).

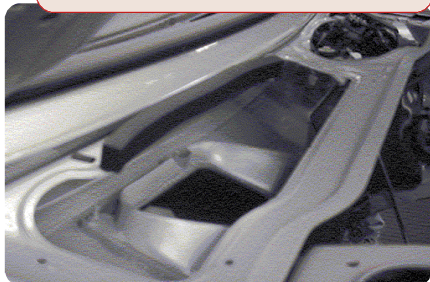
Location of foam

The foam water dam under the black beauty panel may be mis-positioned, missing, or not adhered properly.

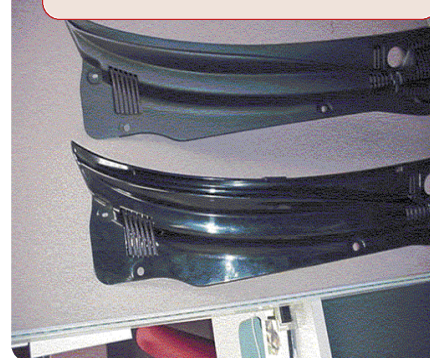
Old style panel, top  
New style panel, bottom
