Allison LCT 1000 Transmission

Contents

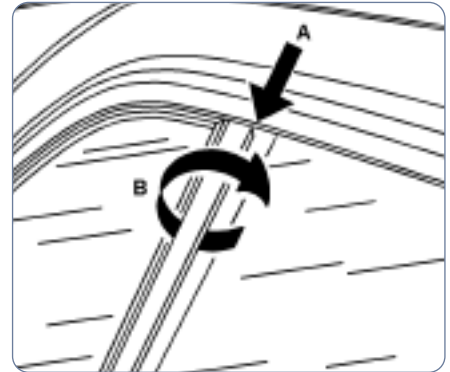
Windnoise at Right Rear Door

Owners of some 2003-04 DeVilles may comment on a prominent windnoise occurring during vehicle travel at the right rear door. The forward leading edge of the upper division post may have a slight gap to the door glass (A in illustration).

To correct this, finesse the upper end of the moulding inboard (B in illustration) approximately 3/32-in. (1-3 mm) to eliminate the gap. Refer to Service Bulletin 04-08-58-003 for further details.
