A Monthly Publication for GM Dealership Service Professionals

# **Fuel Economy Facts and Myths**

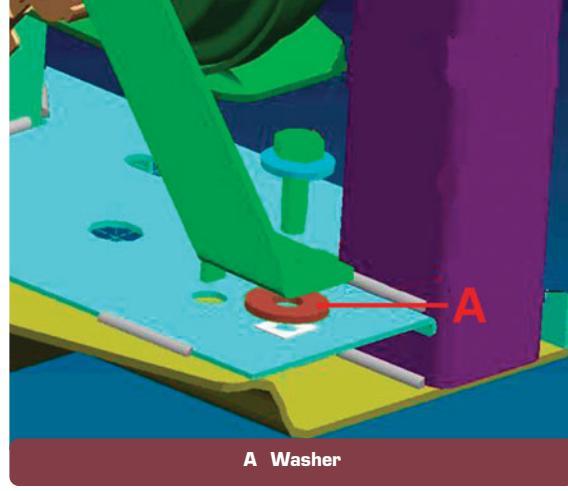
Some owners of a 2007-08 Silverado or Sierra 1500 model may comment that the airbag MIL comes on after repeated use of the horn and the SDM will set DTC B0083 sym 39 (Left Front Electronic Front End Sensor – Internal Electronic Failure). The root case may be the left front electronic sensor responding to the horn frequency during repeated or long horn honks.

If the DTC does not return, the cause could be from repeated or long horn honks. To correct this, install rubber washers p/n 11588485 to insulate the left horn at its mounting location.

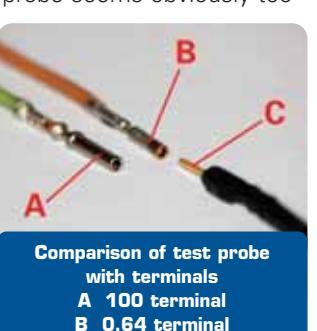
C 0.64 test probe

Crimp Tool

J-38125-643

into a 0.64 female, the 0.64 terminal may split. This destroys the terminal's retention capability. When that damaged 0.64 terminal is reconnected, tension may be too low to ensure proper contact and continuity.

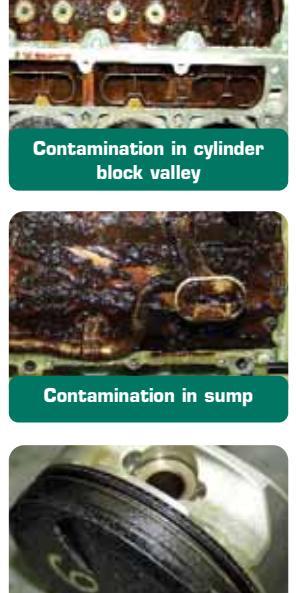
additives to gasoline in an attempt to increase fuel economy, often the results can be damaging. These pictures show 6.2L V8 engine components that were run for less than 3000 miles on gasoline that had a small amount (less than 1%) biodiesel added to it.

**Contamination on piston**

ket additives and devices are not covered under the terms of the New Vehicle Warranty. The only fuel additive currently approved by GM is GM Fuel System Treatment Plus, p/n 88861011 (in Canada, 88861012).
