Testing Fuel Injectors -- Misfires

Techline News

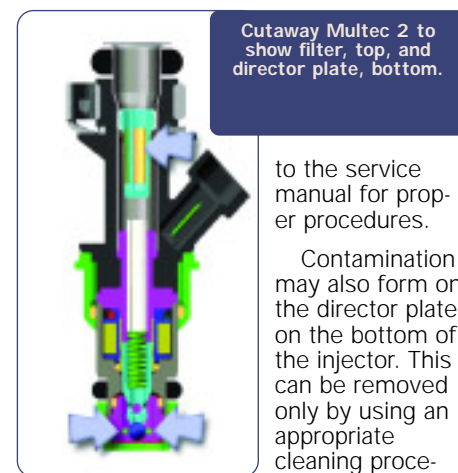
Cylinder Number	Initial Pressure (kPa)	Pressure After Pulses (kPa)	Subtracted Value (kPa)
1	346	165	181
2	345	172	173
3	345	167	178
4	346	187	159
5	345	169	176
6	344	171	173

4. If the **Max Difference** is greater than 20 kPa, you have one or more faulty injectors. The injector with the highest subtracted value delivers the most fuel (rich), while the one with the lowest subtracted value delivers the least fuel (lean). An injector that is overly rich when compared to the others must be replaced. An injector that is lean when compared to the others may have some type of internal contamination causing a restriction.

A filter located at the top of the injector captures large contaminants in the fuel system. It is recommended that you replace the injector if this filter is plugged with debris. You must also closely

inspect the other injectors, the fuel rail and the fuel pump and tank. Clean and/or replace components as necessary. Refer

not all injectors may be cleaned. Refer to bulletins 99-06-04-005B and 00-06-04-003A for specific applications. Repeat the balance test with the new or cleaned injectors to make sure the **Max Difference** is now less than 20 kPa.

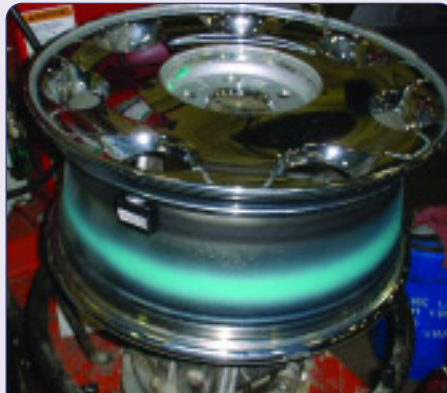
Use care when using tire machine

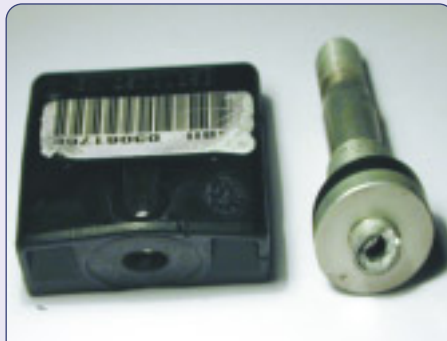
well of the rim. It's important to be careful when using a tire mounting machine. The sensor could be damaged in two ways: either by direct contact with the machinery or by the bead of the tire as it is forced over the rim.

Sensor ruined by tire mounting equipment

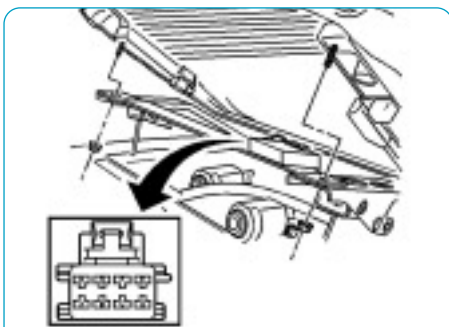
Typical test point for seat heat elements

To find the failed element, measure the resistance values at the appropriate location, as instructed. You will be able to determine if the failed heat element is in the seat back or seat cushion. If all of the resistance values are within the proper range, the problem is not with the heat elements. Refer to the diagnostic procedures in the service manual.

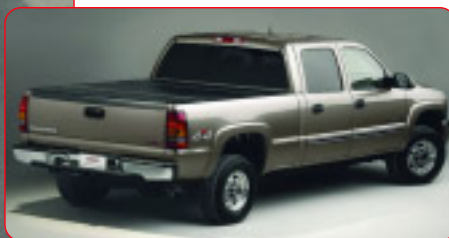
Owners of some early built 2003 model year 1500 HD crew cabs with QuadraSteer option (NYS) may comment about less than optimal ride and handling characteristics (frame beaming, vehicle shake, vibration).

Dealers can replace the "voided " No. 3 body mount (P/N 15059114) and the lower retainer (P/N 15158599) with the new 75 solid No. 3 body mount (P/N 15095732) and lower retainer (P/N 15529853).
