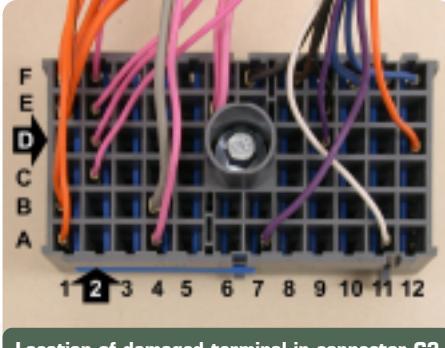
Location of damaged terminal in connector C2

These may be caused by a damaged terminal in the Underhood Accessory Wiring Junction Block (also sometimes called the Underhood Bussed Electrical Center or UBEC). This terminal provides voltage from the IGN 1 30-amp fuse to nine circuits in the vehicle's interior.

If the terminal is damaged, obtain a replacement (p/n 12110844) from tray 4 of the J-38125 Terminal Repair Kit. Install it according to proper SI procedures.

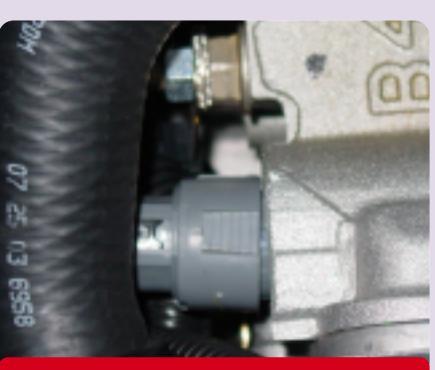
Some customers may comment that the SES lamp is illuminated, accompanied by extremely harsh shifts. The conditions may be caused by an intermittent connection at the transaxle 20-way connector.

Connector not properly seated and locked

Perform an inspection and make the necessary repairs.

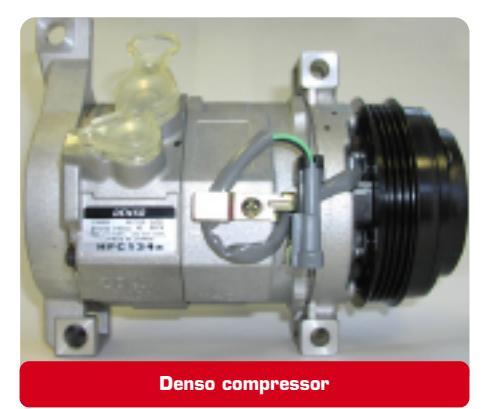
All of these vehicles use a Denso compressor. Customers with these vehicles may comment on underhood noises or insufficient cooling.

TIP: A redesign in April 2003 addressed the reed valve and retainer gasket. Compressors built after April 2003 are redesigned, revalidated and significantly improved. These can be easily identified: the serial number begins with 5E.

TIP: If proper diagnosis pinpoints the compressor as the cause, replacement is the appropriate repair. Compressors built between the dates listed may be more susceptible to these conditions.
