Cruise Control with Electronic Throttle Control (ETC)

Contents

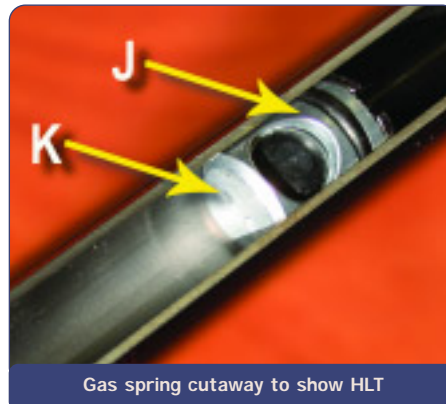
The latest version of the gas spring is called the HLT, or hydro-lift temperature controlled. The name comes from a temperature sensitive bi-metal poppet valve in the piston (J). It's intended to minimize the

Gas spring cutaway to show HLT

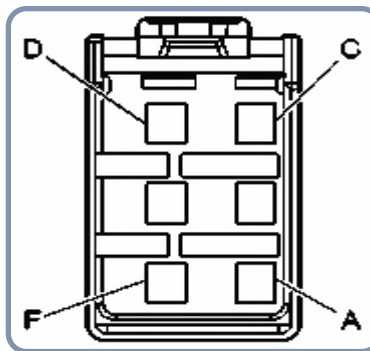
When transferring the brake controller with the wiring jumper attached from a 2001-02 vehicle to a 2003 vehicle, a change to the jumper harness connector must be performed.

To modify a 12171982, 15366255 or 15086884 harness for use in a 2003 vehicle, switch the wires in cavities A and D.

To modify a 15085418 harness for use in a 1999-2002 vehicle, switch the wires in cavities A and D.

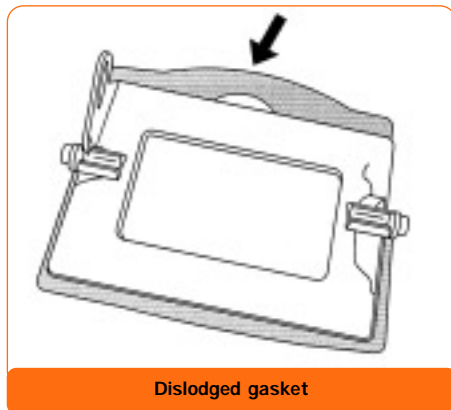
Owners of some 2002-03 Chevrolet Venture, Oldsmobile Silhouette and Pontiac Montana vehicles may comment on a fluttering sound from an I/P air vent when the fan is set on medium or high.

This may be caused by a dislodged strip of foam gasket on one of the air shutters.

Dislodged gasket

Pull the gasket partially out of the retaining groove and apply hot glue three places: at the center, and right and left of center. Reseat the gasket and allow the glue to set.
