Wireless Headphones and Remote Controls

Techline News

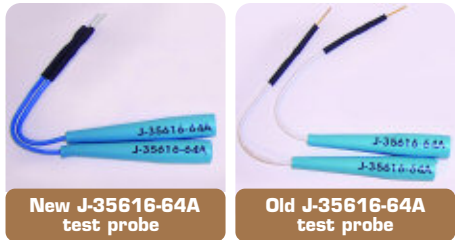
Test Probe

If a male 100 terminal (or test probe, or anything incorrect) is inserted into a .64 female, the .64 terminal may split. This destroys the terminal's retention capability. When that damaged .64 terminal is reconnected, tension is too low to ensure proper contact and continuity.

TIP: The earlier probe has a white wire and a gold terminal probe.

an update to this probe. The latest version has a blue wire and a more robust silver terminal probe. Use the probe carefully to avoid damage to the terminal.

TIP: The J-35616-64A and J-35616-65 test probes are correctly sized to substitute for both the round and square male terminals.

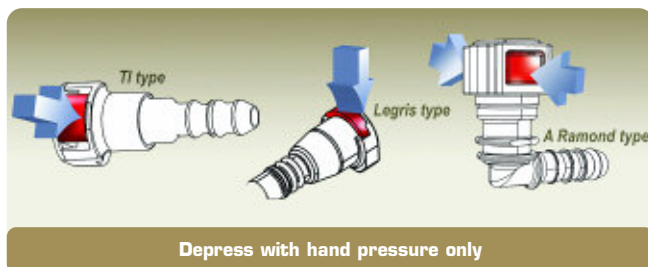
Do not use sharp or pointed objects to put pressure on the connector retainer/release buttons. Using a tool may fracture the retainer, making it less effective at keeping the connector assembled. It may be easier to release the connector if it is first pushed toward the barb on the mating line. If one attempts to release the quick connect while pulling on the con-

TI Group – If the retainer is broken, it is not necessary to replace the entire fuel line and attached component to repair it. Three sizes of replacement retainers are available

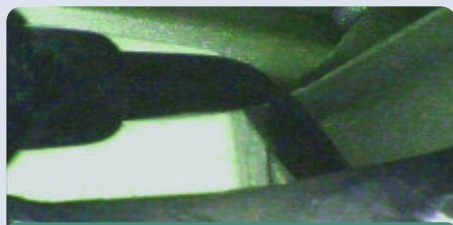
The sunroof drain hoses must be pointing downward from the connection to the sunroof module to ensure water can quickly drain away and to prevent stress on the connecting joint. A stressed joint will slowly drip water onto the headliner and this water can get to the map light.

Incorrectly positioned drain hose

To correct the condition, remove the A pillar trim on the affected side.

Pour a small amount of water into the sunroof module area adjacent to the drain connection. If leakage is evident, the hose may still be pointing slightly upward.

If the leak cannot be stopped, remove the drain hose and seal it to the module.
