Solstice Rear Caster

Techline News

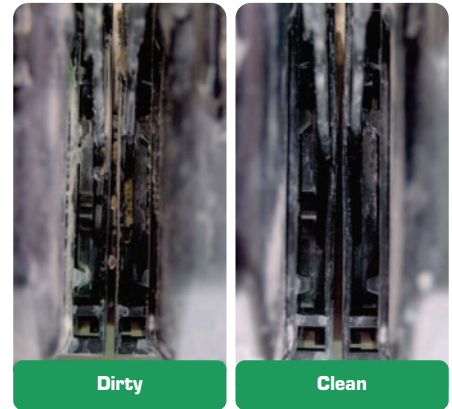
Avoiding PCM Connector Damage

It's important to observe this step on all PCMs, to prevent contamination from getting into the PCM header when the connector seal is opened.

But, it's extra important on PCMs that use assist levers for connector retention. The slides must be pushed or pulled to unlatch or latch the connectors. If there is a buildup of dirt in the slide troughs, the assist lever may be broken when you attempt to move it.

And when you reconnect the harness, be sure that the gaskets are installed correctly. The gaskets prevent contaminant intrusion into the PCM.

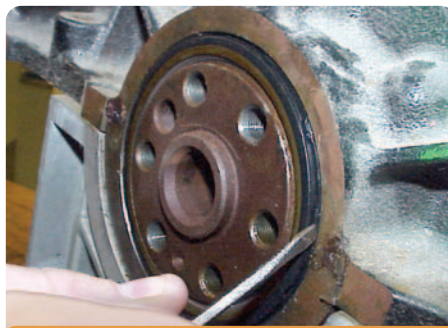
Removing old style seal

A bulletin 05-06-01-019C is being released explaining a new crankshaft rear main seal and a revised replacement procedure, using a newly released tool EN-48108.

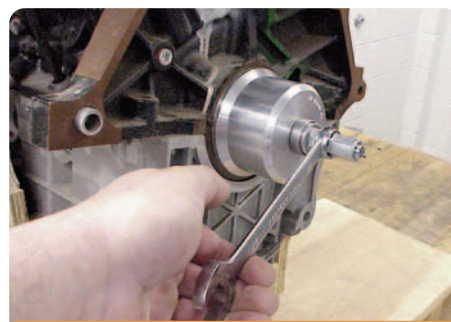
Pushing seal into place

The drum pushes the seal into place, and is stopped when it contacts the engine block.

Follow bulletin instructions for the completion of the procedure.
