A Monthly Publication for GM Dealership Service Professionals

Multiple Diagnostic Interface

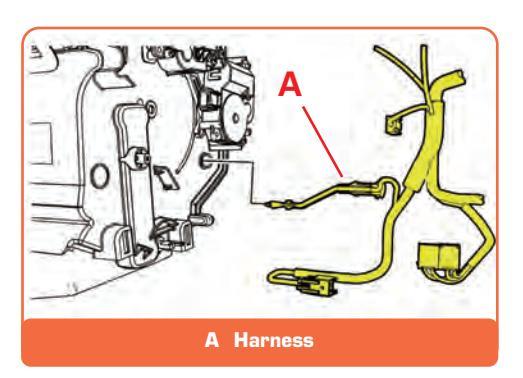
HVAC Evaporator Temperature Sensor

On the 2006-07 DTS and Lucerne, the evaporator temperature sensor is part of the heater and A/C control lamp wiring harness and must be serviced as an assembly. This sensor is used with both manual and automatic control HVAC.

TIP: You can't pry the sensor out without breaking the case.

Pinch the evaporator temperature sensor locator tabs together from the inside of the HVAC case for sensor removal.

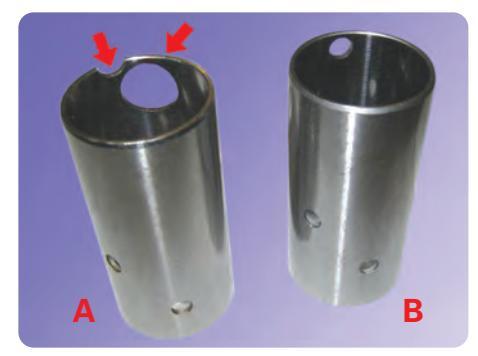
A replacement pump cover may appear different from the original pump cover. The replacement pump casting may have a boss or a hole and plug to accommodate an input speed sensor (ISS).

Using a light, look inside the stator support and inspect the stator support shaft sleeve. If the sleeve has a large hole and notch, it cannot be used in 1997-2005 transmissions. If the sleeve does not have the large hole and notch in the sleeve it can be used in 1997-2005 transmissions.

- A Notch and hole for ISS equipped pump cover – CANNOT be used in 1997-2005 transmissions
- B Non ISS equipped CAN be used in 1997-2005 transmissions
- Thanks to Chuck Krepp

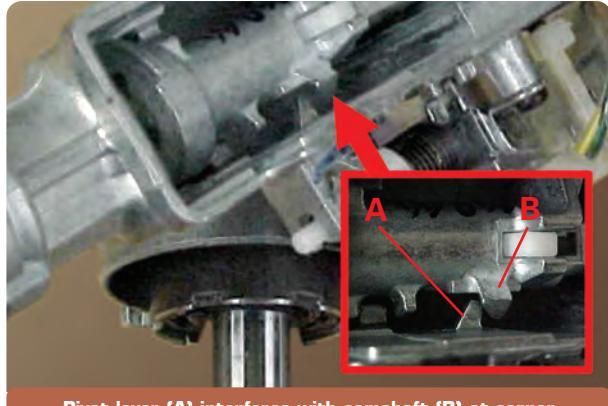
Ignition Key Is Difficult To Turn

Pivot lever (A) interferes with camshaft (B) at corner

On some 2007 Saturn IONs, it may be difficult to turn the ignition key to the Run position.

A tab may be improperly placed in the ignition housing. This will require replacement of the housing on cars from VIN 7S825114 to 7S834111. It cannot be repaired. The part number for the replacement housing is 10392736.

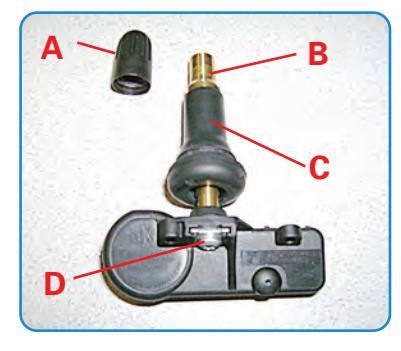
TIP: Replace the valve stem with a new valve stem at each service event.

The TPM sensor can be retained with the vehicle and attached to the new valve stem. The service part kit to replace the valve stem, including a new screw, is p/n 15263240 for all applications.

Torque the retaining screw to 1.3 N-m (11.5 lb-in). *TIP:* The spare tire does not have a TPM sensor.
