A Monthly Publication for GM Dealership Service Professionals

Active Fuel Injector Tester

TECHtink .

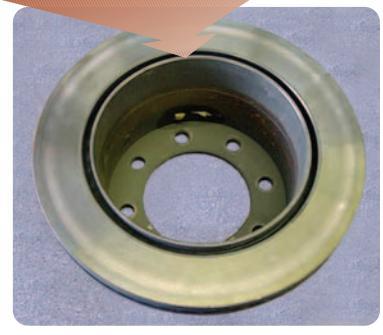
Parking Brake

The knurling looks like fine machine cut lines across the surface of the drum-in-hat. This knurling can be found on new service replacement rotors, as well as new stock units. The purpose is to improve "green" unburnished park brake performance. As the park brake linings get burnished, the knurling wears off.

No repairs should be made. This is a normal condition.

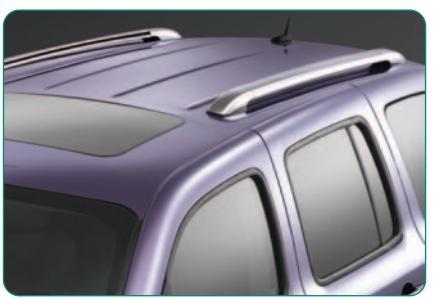
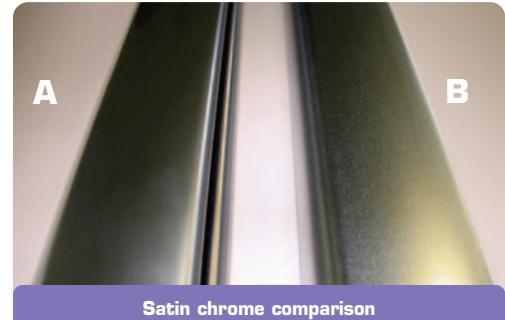
A Original finish B Revised finish

As a result, the satin finish now has a slightly different appearance. This is normal, and no repair or replacement is necessary.

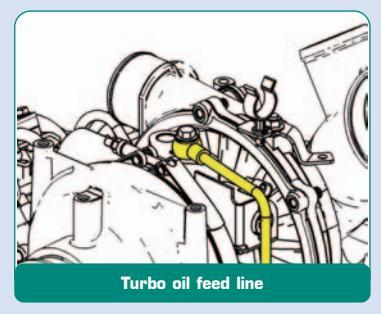
The turbocharger oil feed line is a high pressure plastic tube protected by a stainless steel braided covering. If it is twisted or bent too far during turbocharger removal, the plastic line may fold and kink. The kink may cause an oil flow restriction or an oil leak.

TIP: If the plastic pipe becomes kinked, it will not return to its normal size and shape. The damage may not be obvious when inspected. The braided steel covering will hide the deformity.

During any type of repair that includes turbocharger oil feed line removal, do not twist or turn the line. This type of movement will immediately collapse the plastic line.
