Brake Service

Part 2 — Refinishing and Lateral Run-Out (LRO) Correction

Techline News

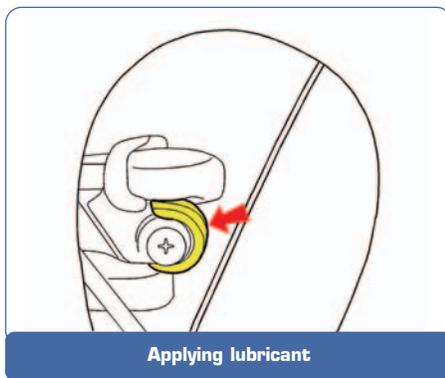
Some customers may comment that the outside door handle on their 2005-06 Chevrolet SSR makes a clicking noise when opening.

Remove the door trim following SI document 1347496. Pull back the water deflector to gain access to the lock cylinder. Apply GM Super Lube p/n 12346241 (10953474 in Canada) to the door handle spring.

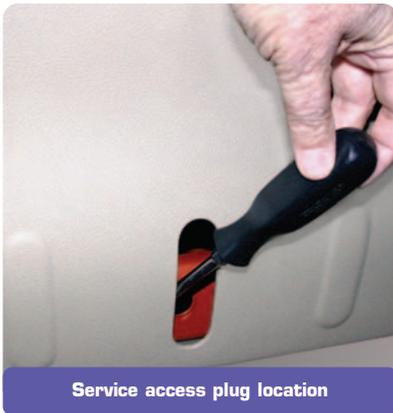
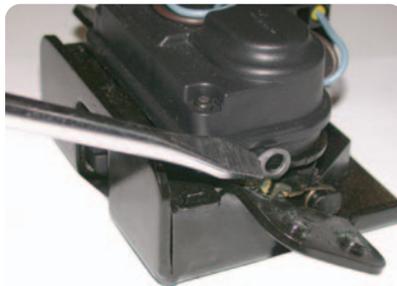
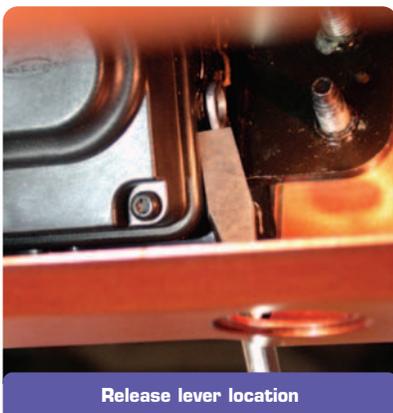
In the case of electrical failure, the lock can be operated manually from inside the vehicle, after a service access plug is removed.

Use a small flat-bladed tool to remove the plug from the trim panel.

Use a light to locate the bellcrank lever, a small metal arm located below and to the left of the access hole.

Use a thin, long (6 in, 150 mm) flat-bladed tool to slowly push the release lever rearward, until the latch releases.

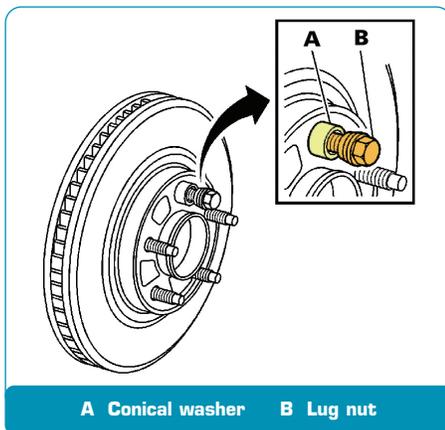
TIP: Conical washers simulate the clamping load of the wheel on the rotor/hub interface to make an accurate LRO measurement.

Hold the rotor flat to the hub. Install J 45101-100 conical washers (A) and lug nuts (B) and finger tighten. Torque the lug nuts to SI specifications using a star pattern.

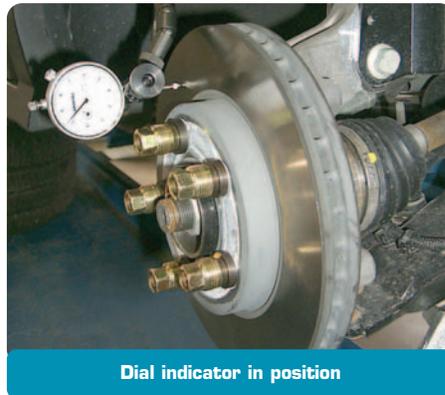
Refer to LRO measurement procedures in SI. On most passenger cars, if LRO is greater than 0.002 inch (0.055 mm), correction is required. P-90/N-car specification is 0.0015 inch (0.038 mm). Always consult SI for the specifications for the model/year vehicle you are working on.

Install a dial indicator J 45101 (or equivalent) to the steering knuckle and position the indicator button so it contacts the brake rotor friction surface at a 90° angle, approximately 0.5 inch (13 mm) from the outer edge of the rotor.

With the dial indicator installed, rotate the rotor until the lowest reading is displayed on the indicator dial and set the dial to zero. Rotate the rotor until the highest reading is displayed on the dial. Mark the location of the high spot relative to the nearest wheel stud, or studs. Mark the studs and rotor to allow you to re-install the rotor to the hub in the same index location. Record the amount of measured LRO on the repair order for the corner of the vehicle you are working on.

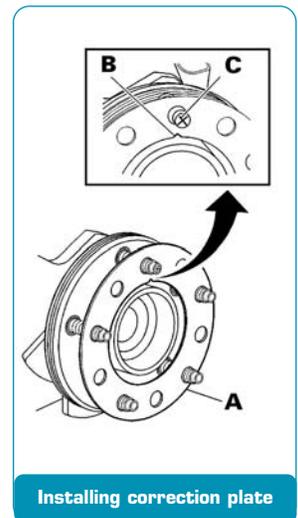
TIP: Brake-Align plates have a double wheel lug pattern of mounting holes to allow positioning the V-notch at a lug location or in between lugs, depending on the location of the high spot mark.

Install the rotor, observing the index marks you made earlier.

Hold the rotor flat to the hub, add a conical washer and finger-tighten the first lug nut. Repeat with the other lug nuts. Tighten to the specified torque, in a star pattern.
