Proper Wheel Balancing Techniques

Bulletin 07-03-10-017 was recently issued to address a wheel balance condition when using an off-car tire balancer.

Techline News

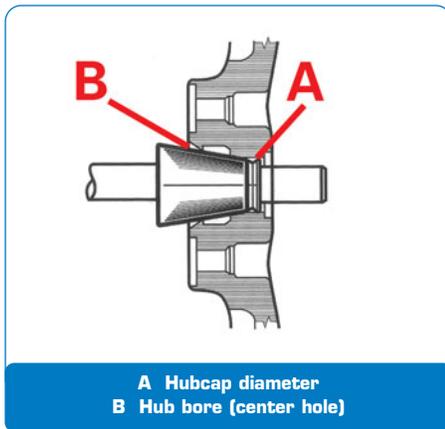
Wheel dimensions are all taken from the hub bore (center hole) of the wheel, and that's where the balancer cone must contact when installed from the back side of the wheel. This is true of both hub-centric and lug-centric wheels.

Some standard wheel balancer cones may not fit the hole properly. The cone may bottom out against the smaller hub-cap diameter (A) instead of contacting the center hole surface (B). If this occurs, the wheel may not be properly centered on the balancer, and the resulting balance is inaccurate.

Before installing the cone to the wheel balancer shaft, check the cone for proper fit to the center hole of the wheel. Make sure it does not bottom out. The side of the cone should uniformly contact the center hole. If it bottoms out at the hub cap diameter and is not supported by the hub inside bore, it may rock. Do not use a cone that exhibits these conditions.

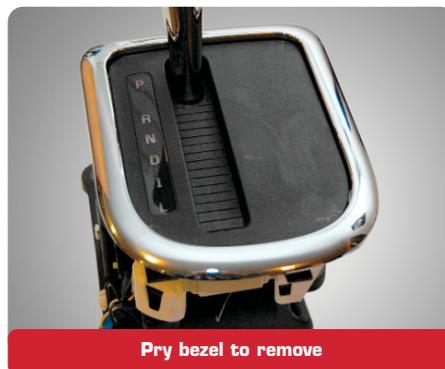
Spilled Beverages – Check to see if beverages have been spilled into the shifter. Beverages are sticky, and can hamper movement of components inside the shifter housing. A customer may have wiped up the easily visible residue, but you can pry off the bezel to look at the top of the shifter housing. With a light, you can peek inside to see if there is liquid on the corrugated strip or in the base of the shifter housing.

Inspect for spilled beverage

Pry bezel to remove

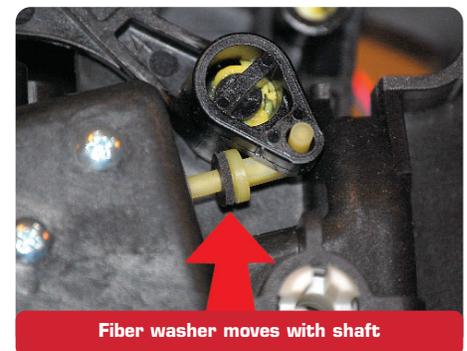
TIP: There is a small fiber washer on the shaft of the BTSI solenoid that is in a direct line below the edge of the housing. If liquid is spilled onto this washer, it may become saturated.

Fiber washer moves with shaft

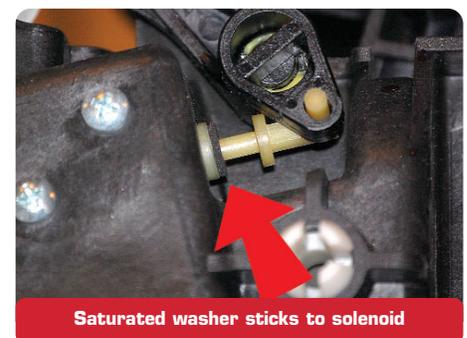
Saturated washer sticks to solenoid

In a normal system, the fiber washer moves along with the shaft. If it has become saturated with beverage, the fiber washer sticks to the solenoid, creating a drag on the shaft, possibly preventing motion.

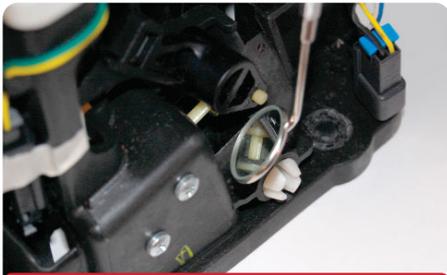
Using dental mirror to inspect fiber washer

TIP: You can use a dental mirror to inspect the fiber washer.

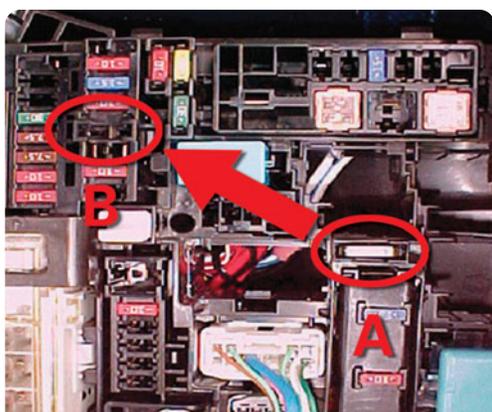
2009 Pontiac Vibe vehicles are shipped with the white unmarked connector link disconnected from the underhood fuse block. The white link is stored in a spare fuse holder (shipping location) in the underhood fuse block. To operate the radio, OnStar, dome lamp, remote keyless entry and/or power door locks properly, the white link must be removed from the spare location and installed into the short DCC fuse cavity.

Move white link
A Shipping location
B Short DCC location
