A Monthly Publication for GM Dealership Service Professionals

Techline News

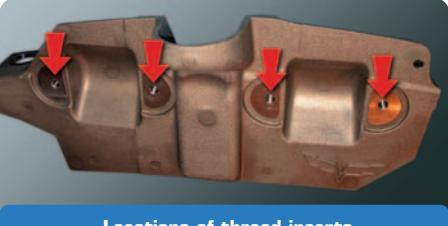
Locations of thread inserts

The frame of the 2006-07 Corvette Z06 is made of aluminum. Holes for attaching various parts to the frame contain threaded steel inserts. In the case of the upper control arms (front and rear), there are 16 attaching points, each with a wire thread insert installed during the manufacturing process.

If one of these inserts

becomes damaged, it's necessary to remove the damaged part and replace it with a solid, thin-walled, key-locking, stainless steel keysert. SI document 1796206 explains the procedure for using the CH 48106 Suspension Thread Repair Kit.

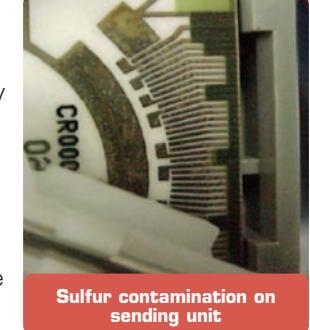
Sulfur contaminants found in some of today's gasolines can form deposits on the sending unit, resulting in higher-thanintended resistance (TechLink, Jan. 2006). The high resistance from the deposits could be misinterpreted as a high fuel level, when in fact the fuel level is low. The driver may run out of fuel, even though the fuel gauge is not indicating low or empty.

To offset this effect, engineering has begun "flipping" fuel senders, reversing the circuitry. This means that high resistance now indicates low fuel level and low resistance indicates high fuel level. So, if deposit build-up adds to sender resistance, the gauge will err in the direction of indicating less fuel than is actually in the tank.

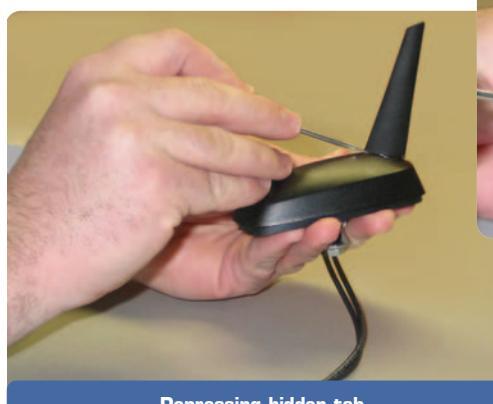
Depressing hidden tab

If the improper procedure is used to remove the mast, the base may be

broken or the mast may be gouged. A hidden

A hidden locking tab must be depressed to remove the mast from the

antenna base. Insert a small screwdriver between the mast and the base to depress the locking tab while turning the mast to unthread it from the base.

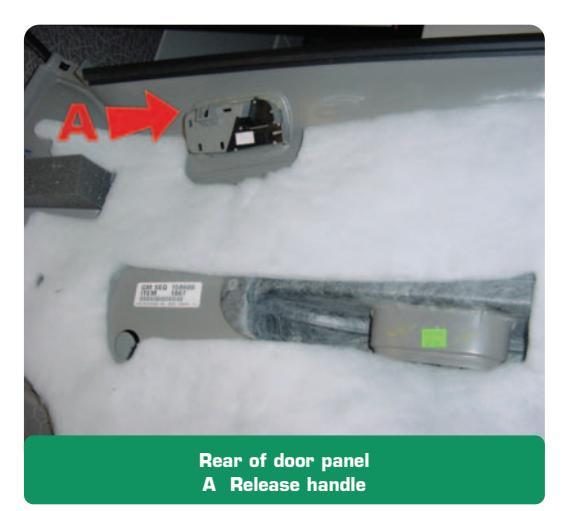
When removing the inside release handle, be sure to remove the door trim panel first. Many of these vehicles have a small amount of hot-melt adhesive applied to the back surface of the door trim. Remove this adhesive before attempting to remove the release handle. Failure to do so will result in damage to the door trim.

TIP: It is not necessary to apply adhesive to the inside release handle. This application was for manufacturing purposes only and the release handle may be installed without adhesive.

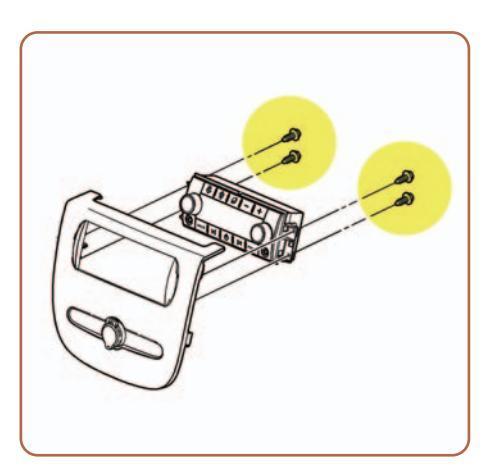
If the fasteners on one side of the module are tightened before the other side, there is a high probability that the module will not seat correctly.

To ensure that the module is seated correctly, insert all 4 fasteners half-way. Then tighten to the final torque of 1.5 Nm (13 lb in).

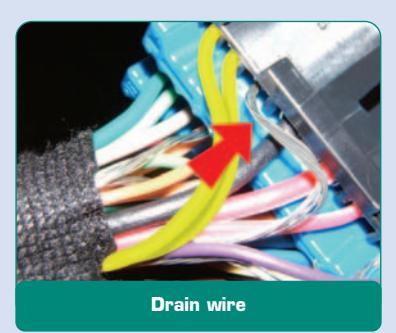
Some owners of the 2007 Chevrolet Tahoe, GMC Yukon and Cadillac Escalade with RPO (UQA or UQS) may have a concern with a buzz, whine, distortion, pop, or static noise coming from any speaker.

Inspect for contact between the radio low level signal drain wires and any adjacent terminal at Connector C211. The drain wires are bare and may have excessive length that can allow them to contact adjacent terminals on the back side of the connector. This can be corrected by pulling back unnecessary slack in the drain wires and securing them with electrical tape.

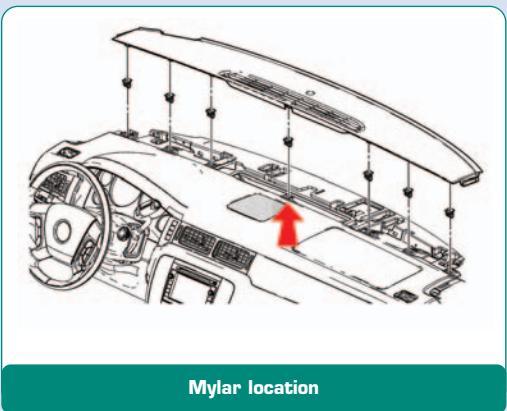
Owners of some 2007 Cadillac Escalade. Chevrolet Tahoe, and GMC Yukon vehicles may comment that the Instrument Panel Upper Trim Panel appears to be lifting or seems loose in the area of the windshield defroster grille or at the ends of the trim panel.

Replace all 7 clips that hold the upper panel in place with GM p/n 11589329. After replacing the clips and before installing the upper trim panel, locate the center hole in the I/P carrier where the center clip goes when the panel is in place. Check the locating hole for a piece of mylar tape. If mylar tape is in the center hole, remove the tape from the center hole only. Re-assemble the upper trim panel.

TIP: Don't remove the mylar tape from any other clip locating hole.
