A Monthly Publication for GM Dealership Service Professionals

General Motors DEXRON®-VI

Global Service-Fill Specification

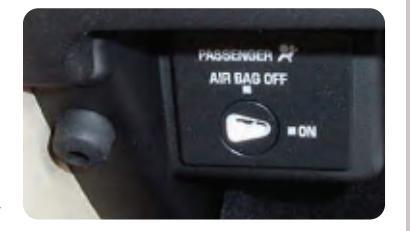
On these vehicles some customers may comment that they cannot locate the passenger airbag toggle

switch, which on earlier models was located on the right side of the instrument panel.

For the 2007 new style HD pickups, the on/off switch is located in the primary glove box.

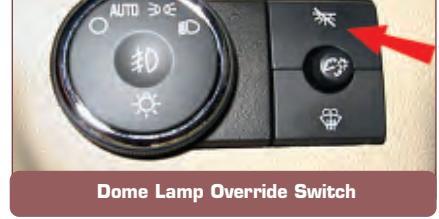
Does Not Come On -- The dome lamp may not come on when the doors are opened, but will work when manually turned on. These vehicles are shipped with

the dome lamp override activated. It is also possible to press the switch when adjusting the dimmer switch, and not know it has been activated.

Before making any repairs, be sure the dome lamp override is not activated by pressing the switch and then rechecking the dome lamp operation.

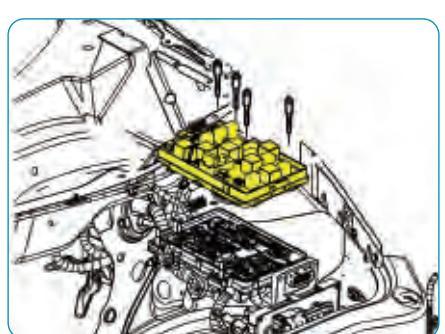
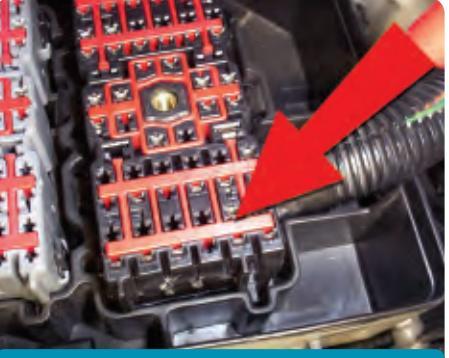
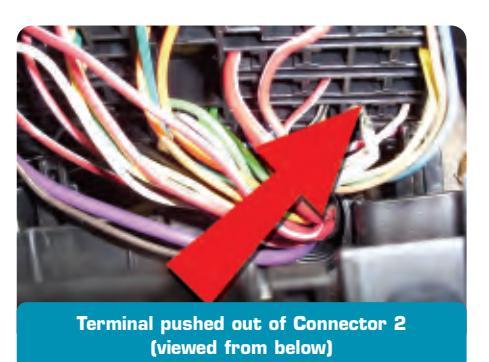
The no-start condition may be caused by a damaged terminal in the fuel pump relay circuit in the Underhood Bused Electrical Center (UBEC).

The condition occurs if the male terminal on the bottom of the UBEC does not squarely enter the female terminal of the wiring harness connector. In some cases, the female terminal is pushed out of the connector and the locking finger is sheared off. In other cases, the female terminal becomes deformed and damaged. Regardless, the connection is not secure, and can easily become intermittent.

This condition is most likely to affect the fuel pump relay circuit 120, which passes through terminal E2 of Connector 2.

When continuity in this circuit becomes intermittent, the fuel pump does not run.

Damaged terminal in Connector 2 (viewed from top, with electrical center board removed)

Once the condition is located. replace the damaged components. Terminals for the harness connector are available in your Terminal Repair Kit J-38125-G. The connector with spacer and components for the UBEC are available from Service Parts Operations. If the UBEC terminals are damaged (top or bottom), a new UBEC must be installed.

IMPORTANT: Do not replace the fuel pump relay or fuel pump and sender assembly for this condition. Replacing these components will not resolve the

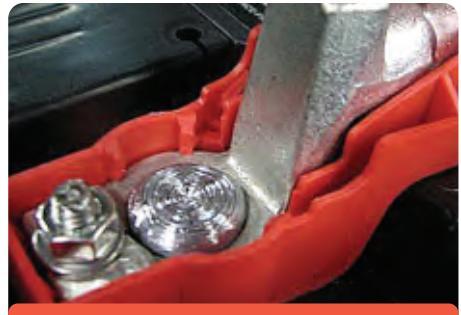
The battery post should extend 3 mm above the cable clamp before the nut is torqued. The cable clamp should not be flush with the battery post.

Battery cable installed correctly

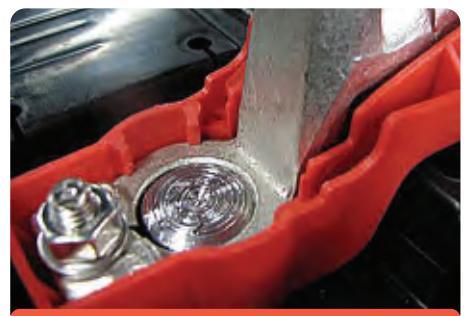
If the battery clamp is flush, the clamp load will not be high enough to maintain a solid connection and could cause one of the concerns above.

Battery cable installed incorrectly

If the cable clamp is not installed correctly, install the cable correctly and charge the battery if needed.
