Pontiac G8

Techline News

Transmission Tick Flutter Noise at Highway Speed

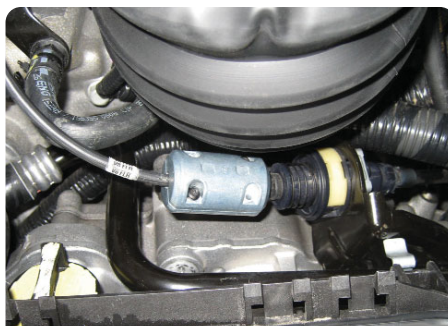
On some 2007-08 Cadillac DTS vehicles equipped with 4T80E MH1 transmission, a ticking/fluttering noise can be heard in the vehicle at highway speed.

The noise is generated by the modulation of the TCC solenoid. Movement within the solenoid excites the shift cable, resulting in a low level, high frequency noise that can be heard in the passenger compartment

Damper located on shift cable

To correct the condition, install a solid lead clamp mass damper to the cable. This has been shown to significantly reduce or eliminate the noise.

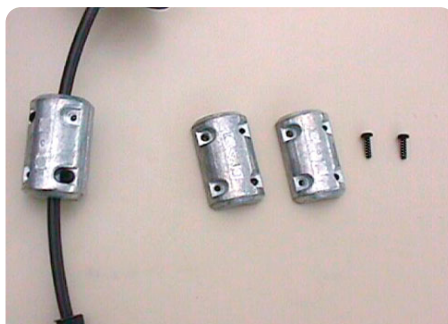
Damper details

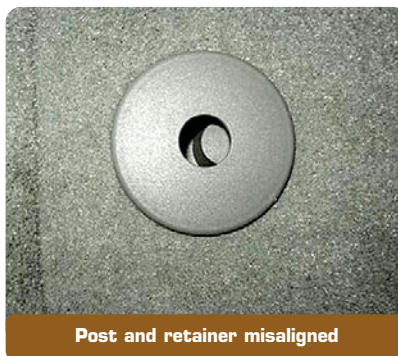
Post and retainer misaligned

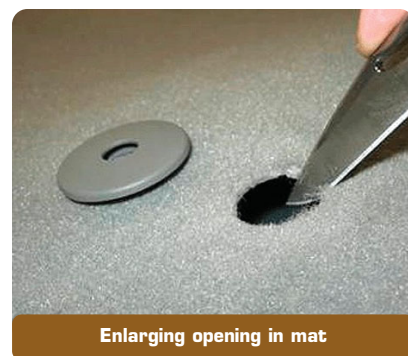
Enlarging opening in mat

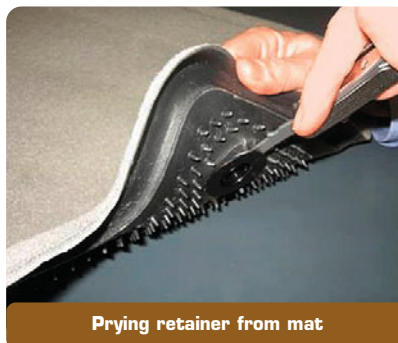
Prying retainer from mat

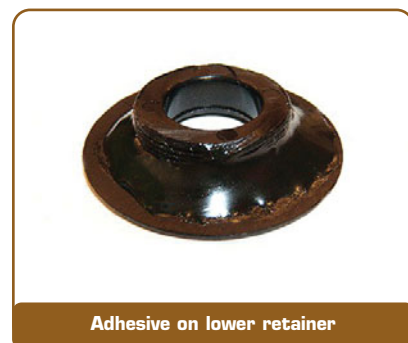
Adhesive on lower retainer

Reassemble the retainer to the mat. Before pressing the two halves of the retainer together, apply a thin coat of Instant Gel Adhesive, p/n 12345632 (10953475 in Canada) or equivalent, to the inside flange of the lower piece. This will secure the retainer to the backside of the mat and prevent movement of the retainer.
