Remote Vehicle Start

Table of Contents -- November 2003	
Remote Vehicle Start	1
Unable to Program Replacement PCM	2
Passkey III+ Key Data Retrieval	2
Child Comfort Clip	3
Outer Tie Rod End Service Kit	3
Using "Getting to Know" Materials Effectively	4
Rotten Egg Exhaust Odor	4
Trim Panel Removal	4
Squeaking Seatback Clip	4
XUV Rear Wiper	5
Interior Light Override Feature	5
Seat Belt Extender	5
RCOHT Oxygen Sensor	6
Memory Seat Calibration	7
Oil Viscosity Usage	7
AC Vent Louver Repair	7
Poor HVAC Blower Vent Performance	7
Fix It Right the First Time	8
Know How Broadcasts for December	8

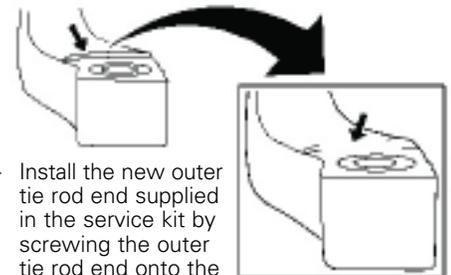
- a revised tie rod end with improved boot that eliminates the possibility of water intrusion into the tie rod end which can cause premature wear out condition
- emory cloth
- an instruction sheet.

- Ensure that the sharp edge and the flashing on the knuckle are removed from the outer tie rod end boot/seal area.

use the improved tie rod end service kit and modify the knuckles according to this procedure.

IMPORTANT: When sanding the knuckle, AVOID REMOVING excessive material. USE ONLY the emory cloth supplied in the service kit. DO NOT use any other abrasive, which may remove excessive material from the knuckle.

- Install the new outer tie rod end supplied in the service kit by screwing the outer tie rod end onto the inner tie rod end assembly.
- Turn the outer tie rod end as many turns as it took to remove the old outer tie rod end from the inner tie rod end assembly.
- Install the prevailing torque nut to the outer tie rod assembly.
- Inspect the front toe and adjust if necessary. Refer to Front Toe Adjustment, SI Document 580777.

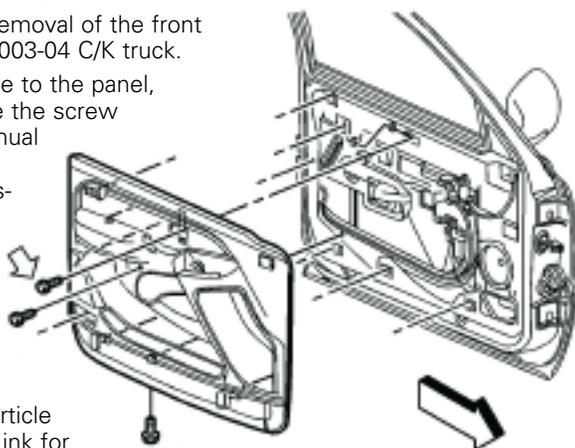
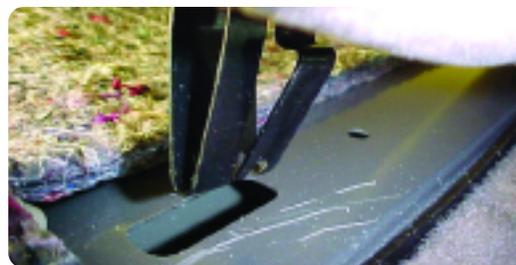
TIP: To avoid damage to the panel, don’t forget to remove the screw hidden behind the manual lock lever, indicated in the accompanying illustration.

This screw is referred to as number 2 in the SI procedure.

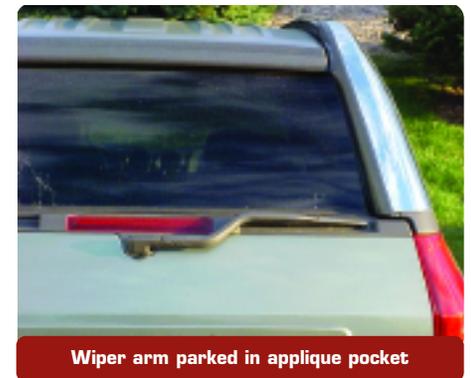
TIP: If the timing is not done, the wiper arm will not park properly, and may interfere with the operation of the end gate window.

Wiper arm parked in applique pocket

1. With the rear wiper arm removed, turn the ignition to RUN, with the engine OFF.
2. Turn the rear wiper switch to full speed (position 3) and verify that the wiper arm pivot shaft is functioning.
3. Locate and remove the rear wiper fuse No. 9, located under the LI rear seat. Verify that the wiper arm pivot shaft is NOT functioning.
4. Turn the wiper switch OFF.
5. Install fuse No. 9.
6. Turn the ignition to LOCK OFF.

7. Install the washer hose end connection into the end gate, route the hose clockwise around the shaft and connect to the elbow.
8. Install the rear wiper arm. Align the park finger of the arm into the park pocket in the applique.
9. Tighten the nut to 6-10 N.m (55-89 in.lb.).
10. Secure the wiper arm nut cover.
11. Turn the ignition to RUN, engine OFF.
12. Cycle the rear wiper and verify the park location of the wiper arm into the applique pocket.
13. Inspect the operation of the end gate window.

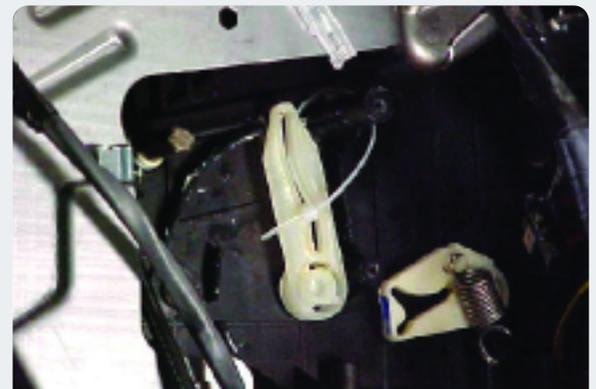
Tie strap around attachment boss

7. obstructed by the tie-strap.
7. Install actuator mounting plate.
8. Install temperature actuator.
9. Reconnect actuator wiring connector. Cycle the temperature door from full cold to full hot a few times and check proper operation.
10. Reinstall passenger side lower IP trim, glovebox and door, and hush panel.
