A Monthly Publication for GM Dealership Service Professionals

# **Revised Brake Bleeding Procedure**

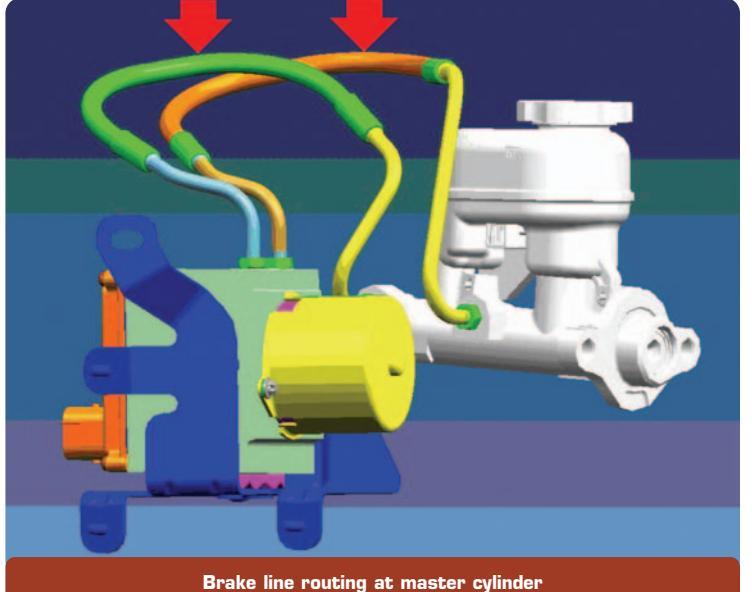
The brake bleeding procedure in SI has been revised for the 2006 Impala and Monte Carlo. Refer to document 1700002 for details. In the brake lines between the master cylinder and the ABS module, there is a point at which the brake line is routed higher than the master cylinder reservoir.

If air gets into this line, due to a disconnected component, it will rise to the high point in the line and care must be taken to purge all of it from the lines.

First, use pressure bleeder J-29532-A.

Second, carefully loosen the fittings on the lines between the master cylinder and the ABS module just enough to be able to rotate the lines temporarily below the level of the reservoir, then tighten the fittings.

Third, perform the bleeding procedure. During this time, you will bleed the left front/right rear diagonal pair of wheel cylinders. Then the right front/left rear diagonal pair of wheel cylinders. This increases fluid flow, to assist in purging air from the lines.

Fourth, when the bleeding procedure is complete, carefully loosen the fittings on the lines repositioned earlier. Move them back to their original positions and retighten.

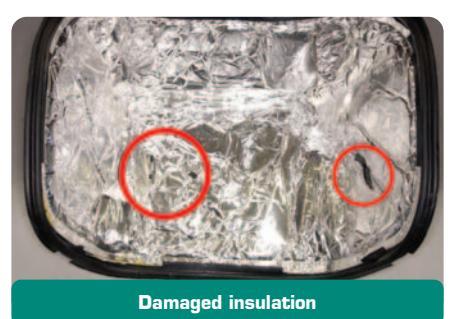
On the G-Van, the bottom side of the engine cover is lined with insulating material. For 2006 with the diesel engine, several engine components are close to the insulation when the cover is in place: turbo variable pitch vane sensor, Fuel Operated Heater (FOH) coolant pipe clamps, and the Glow Plug Module heat shield.

The insulation can be ripped if the cover is carelessly handled.

To avoid damage to the insulator, use care when removing the cover. But take even greater care when installing the cover. Keep it level. Do not force it into place or strike it with your hand to seat it.

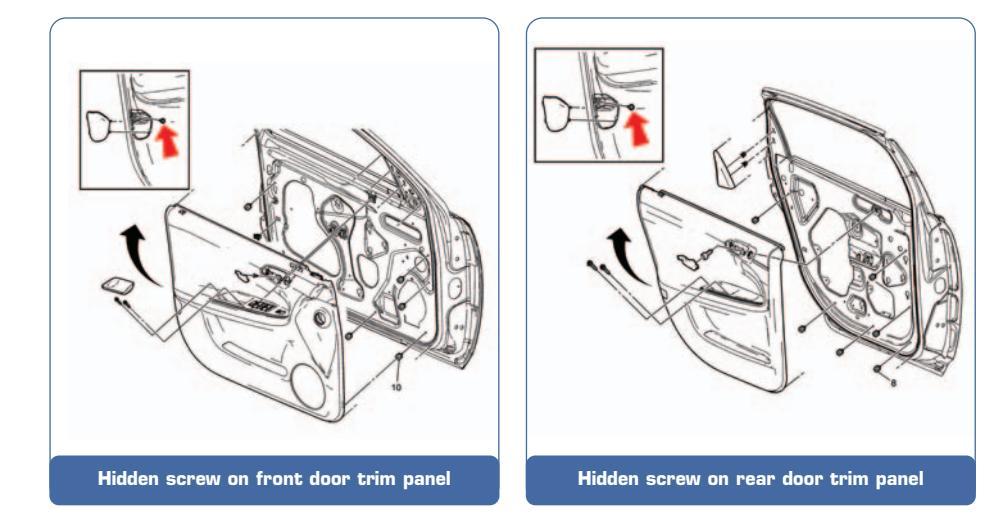
On the front and rear doors of the 2006 Impala, there is a screw hidden behind the reflector at the rear edge of the trim panel. Remove the reflector for access to the screw. The door panel will be damaged during removal if this screw is not first removed.

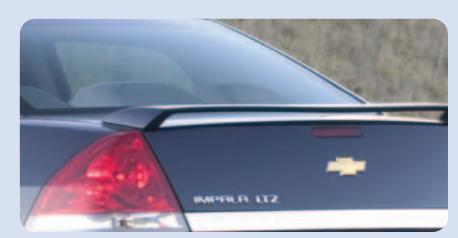
There have been reports of suction cup marks appearing on the outside of the rear window of some 2006

Chevrolet Impalas. The marks are most noticeable when there is moisture on the rear window.

The marks are caused by the machine that installs the rear window glass. The machine's suction cups may leave a trace amount of silicone, causing the marks on the outside of the rear window.
