A Monthly Publication for GM Dealership Service Professionals

2008 Two-Mode Hybrid

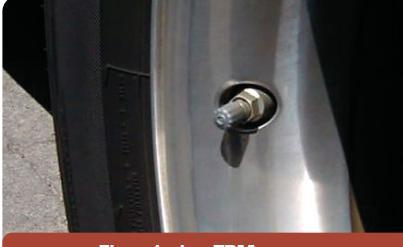
2007 full-size utility models built before October 2006 were built with 1st design TPM sensors with the valve stem integral to the body of the sensor. The 1st design TPM sensor can be visually identified by the aluminum valve stem and retaining nut.

First design TPM sensor

TIP: The 1st design TPM sensor is no longer available from GMSPO and must be serviced with the 2nd design TPM sensor. The 1st and 2nd design sensors are physically and electronically interchangeable.

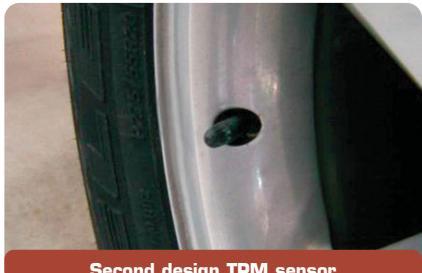
2007 full-size utility models built after October 2006 were built with 2nd design TPM sensors. The body of the sensor is attached to the valve stem with a small Torx fastener. The 2nd design TPM sensor uses a valve stem made of black rubber and looks much like the traditional rubber valve stem. Service parts are available to service the 2nd design sensor and valve stem individually.

Second design TPM sensor

TIP: Owners of utility trucks built before October 2006 (1st design TPM sensors) may object to the visual difference between the 1st and 2nd design parts on the same vehicle. In these cases, it is acceptable to use an alternative TPM p/n 15268606 which is also electrically and visually compatible with the 2007 full-size utility truck. This TPM sensor is not released with application for full-size utility trucks, but the sensor will operate correctly in this application and will closely match the 1st design part appearance.

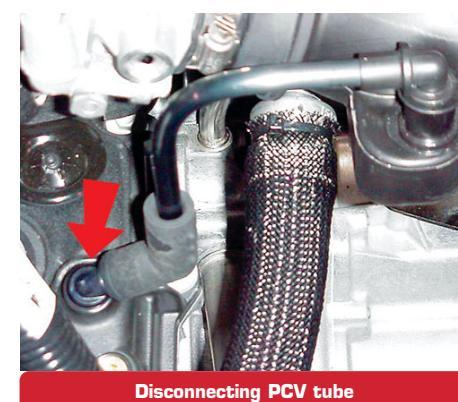
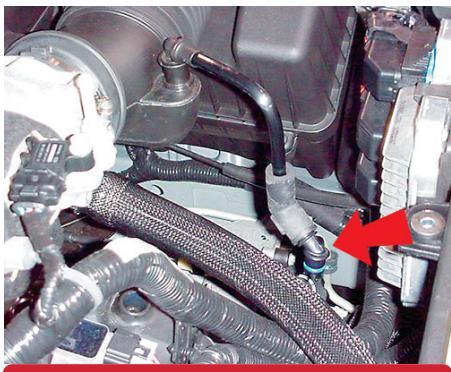
On the Acadia, OUTLOOK and Enclave, the positive crankcase ventilation (PCV) fresh air tube is difficult to remove from the outlet duct. It is very easy to damage the outlet duct to PCV tube interface point when attempting to remove the tube. Once the Fuel Injector Sight Shield is removed, the tube can be easily disconnected from the camshaft cover and repositioned out of the way, without having to remove it from the outlet duct assembly.

Repositioning PCV tube

TIP: Refer to SI document 1860669.

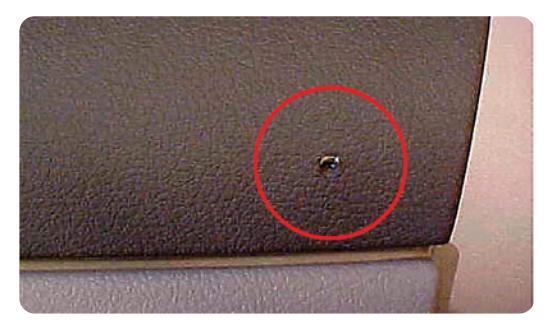
If care is not taken, it would be possible to drill holes through the trim panel, damaging the appearance of the upholstery.

Several cautionary notes about drilling have been added to the procedure.

Step 5: Do not use a drill bit to remove the beltline flange.

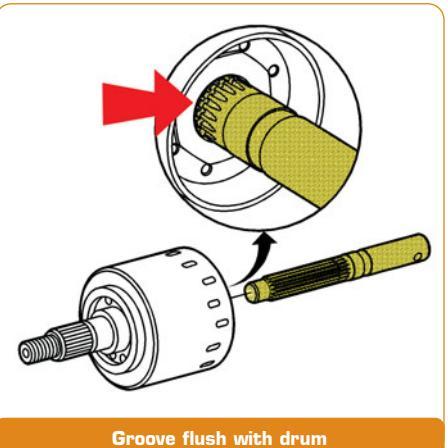
This information applies to the Equinox, Torrent and VUE equipped with All Wheel Drive. An incorrect service procedure when installing the rear differential clutch drum assembly can cause a ticking noise.

Perform this step correctly, as shown in SI. Do not attempt to force or hammer the alignment tool into the clutch drum. Do not use the pinion shaft to perform the alignment function by installing the clutch drum onto the shaft without using the alignment tool. Using the alignment tool correctly assures that no damage occurs to the internal components of the clutch drum. If damage occurs to the clutch, the pump, or the pump bushing, a ticking noise will result.

When installing the differential clutch drum assembly to the pinion shaft of the differential assembly, one of the first steps is to align the clutch with the pump and pump bushing. This is done by placing alignment tool J 46607 in the splines of the clutch. Twist

the alignment tool back and forth to align the pump and bushing. With a properly aligned clutch, the groove on the J 46607 will be flush with the drum. Remove the tool by pulling straight out.

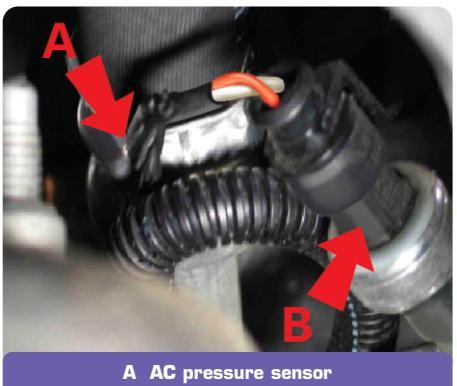
Some owners of a 2007 Silverado or Sierra may comment that the A/C compressor is inoperative, SES MIL, and/or the engine does not continue to run. The ECM may have set one or more of the following DTCs: P0341, P0452, P0532 and P0641.

The A/C pressure sensor 5 volt reference circuit 2700 may short to ground at the A/C

B Short to ground

hose. To correct this concern, repair the wiring and secure the harness to provide the condition from reoccurring.

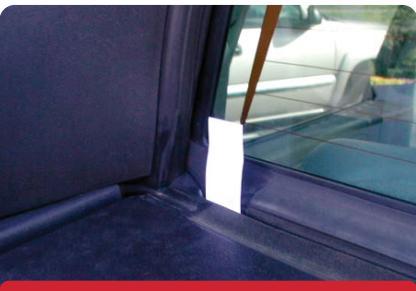
Check the seal clearance where the leak is observed. At the midgate to front cover 1 interface, the thickness of a sheet of paper (about 0.1 mm) is the maximum thickness that can be placed in the seal interface.

Using paper as a thickness gauge
