A Monthly Publication for GM Dealership Service Professionals

# Midtronics PSC 550 Battery Maintainer Now Essential

### **Techline News**

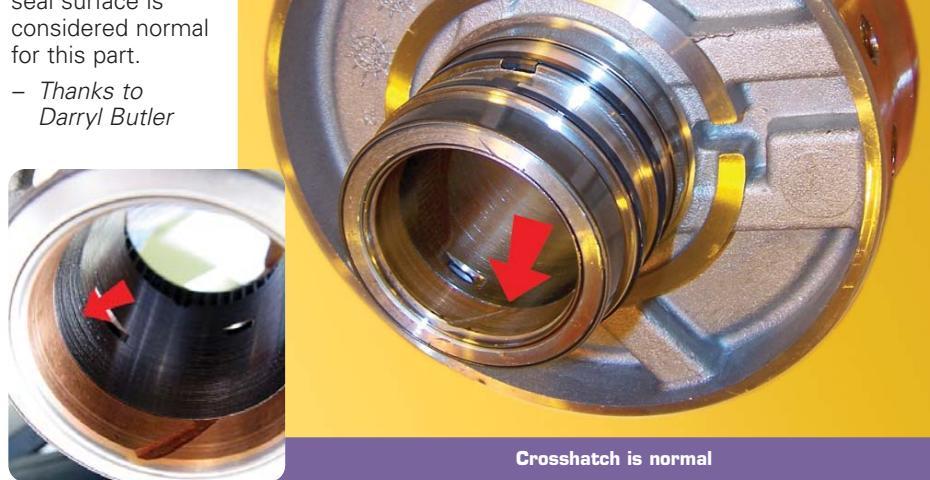
This information applies to the driven sprocket support assembly p/n 24209098 used in the 4T65E transmission (RPO MN7, M15, M76).

The machined crosshatch appearance on the inner seal surface is considered normal for this part.

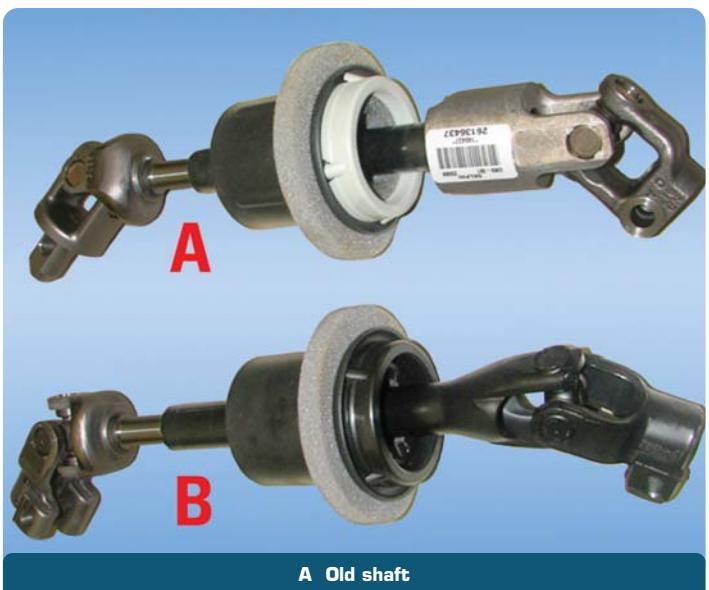
B New shaft with black coating

The 2009 Malibu, G6 and AURA are being built with new intermediate steering shafts (I-shaft) that do not use grease at the sliding interface. The sliding interface consists of a 10 tooth plastic over-molded male shaft and a 10 tooth female shaft that is painted with a corrosion resistant autophoretic coating. The sliding interface was designed to operate without grease. Applying any type of grease or foreign substance to the sliding interface will significantly degrade the performance of the part. DO NOT APPLY GREASE TO THE INTERMEDIATE STEERING SHAFT SLIDING INTERFACE.

Two different I-shafts are being produced, one for vehicles equipped with hydraulic power steering and another for vehicles equipped with electric column power steering. Both I-shafts have a female tube that is painted black, which makes them easy to identify.

New I-shafts have also been released for service. The service parts also have a black female shaft. The service I-shafts are the same as those used in production and should never have grease applied to the sliding interface.

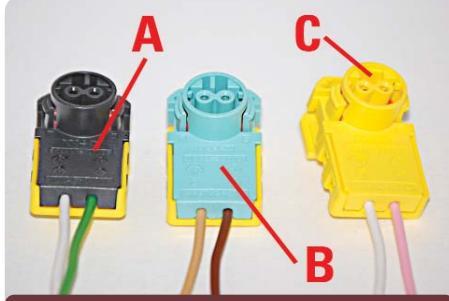
Molex connectors A Code number B Colored body C Keying tab

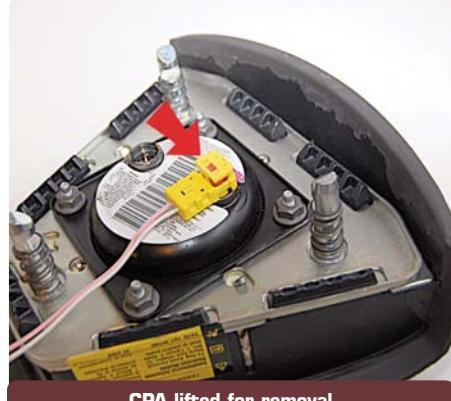
CPA lifted for removal

IMPORTANT: Do not remove the CPA from the connector. If it is removed, it will be damaged and the connector will have to be replaced. There is no replacement CPA. Order a new pigtail and splice it into the harness.

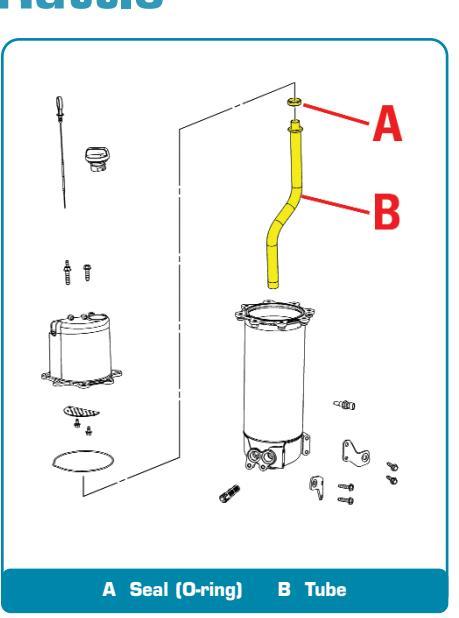
This noise may be caused by the internal transfer tube in the engine oil tank hitting the inside of the tank cover. The seal (O-ring) that secures the tube in place may split and slide down the tube, allowing the tube to be loose.

- 1. Remove the engine oil tank from the vehicle. Refer to the Oil Tank Replacement procedure in SI.
- 2. Remove the eight bolts that secure the tank top.
- 3. Separate the tank. Check the seal (O-ring) for proper position and damage. Replace the seal (O-ring) if damaged with P/N 24576940.
- 4. Reinstall the tank top and secure with the eight bolts.
- 5. Install the engine oil tank into the vehicle. Refer to the Oil Tank Replacement procedure in SI.
- Thanks to Jamie Parkhurst

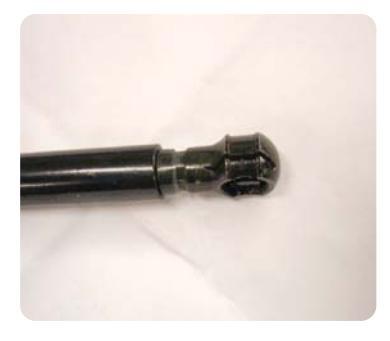
On a 2008 Enclave, Acadia or OUTLOOK, the power liftgate may be inoperative if the power liftgate strut rod retaining clip is not properly oriented. This may happen if the ball socket of the strut rod was not properly machined (socket may not be deep enough). This can prevent the retaining clip from fully seating, which could allow the strut

rod to disconnect at the motor actuator arm.

Do not replace the power liftgate motor assembly for this concern.

If the power liftgate is inoperative, replace the power liftgate strut rod with current SPO parts. Then perform these steps to verify proper orientation of the retaining clip.

- 1. Cycle the power liftgate 5 times.
- 2. While holding the liftgate halfway open, inspect the strut retaining clip by viewing it through the jack cover opening.
- 3. Verify that the clip has not fallen off or slipped down the shaft of the strut. The clip should be centered over the socket.
- 4. If the clip is not centered, replace the strut rod.
- Thanks to Gary McAdam
