A Monthly Publication for GM Dealership Service Professionals

Wheel and Tire Balancing

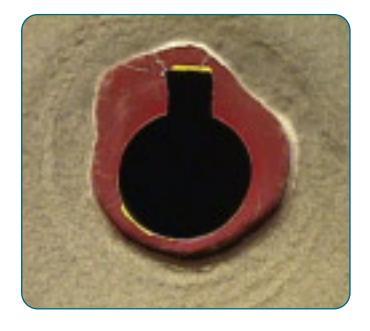
Roof Sheet Metal Inspection

sequence will ensure the integrity to the roof sheet metal. In the event the sunshade was removed before reviewing the service manual, inspect the roof sheet metal for any potential degradation and straighten the effected areas before installing the sunshade.

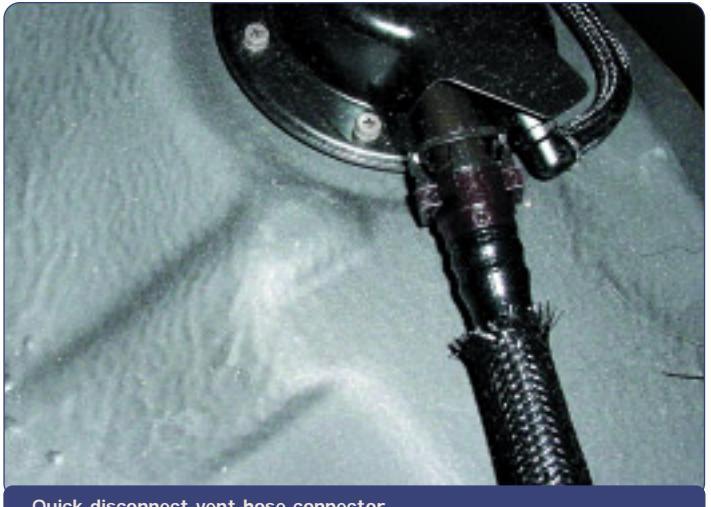
Quick disconnect vent hose connector

This condition can affect All Wheel Drive Pontiac Vibes. With the check engine light illuminated, there may be DTCs P0440, P0441, P0442 and P0446. The codes refer to a condition with the EVAP system, most often with the fuel tank vent hose connection at the ORVR valve. The valve is located at the top right corner of the fuel tank.

When the tester starts to force smoke through the EVAP system, you will notice smoke leaving the EVAP canister vent hose. This is normal. Pinch off the vent hose before looking for signs of a leak. If smoke is found to be leaking from the top right front corner of the fuel tank, the plastic quick disconnect vent hose may either be partially disconnected or there is too

Retest the system with the EVAP system tester. If you still see smoke, rotate the vent hose toward the center of the vehicle. Remove the vent hose from the side of the fuel tank. Grasp the hose at the top of the tank and gently move the hose toward the middle of the vehicle. You should only have to move the valve slightly to correct the leak.

Retest the system for leaks. When the leak is corrected, you will no longer notice smoke leaving the EVAP system. Make sure you clear the DTCs before returning the vehicle to the customer.

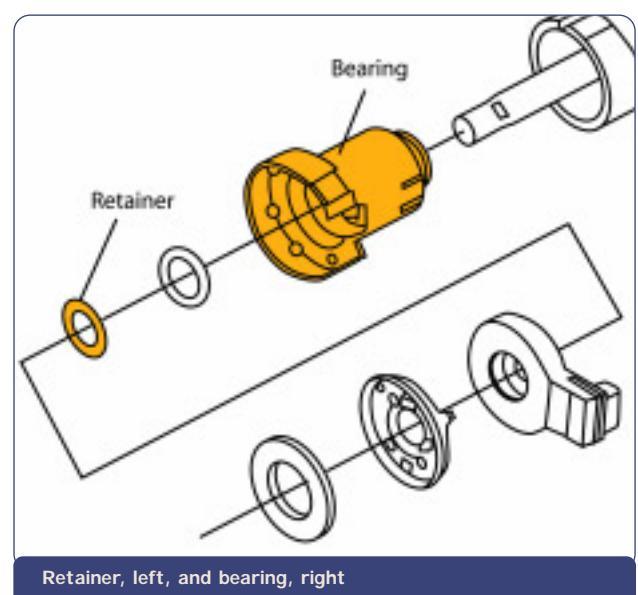
Owners of some 1998-2002 Cadillac

Sevilles may comment about a clunking or rattling noise heard while travelling over bumps. The sound comes from the lower steering column, and may be caused by the clearance between the steering shaft and lower steering column shaft bearing.

A new bearing 26100500 and retainer 07847029 have been released to address this condition.
