A Monthly Publication for GM Dealership Service Professionals

2004 Secondary AIR Injection System

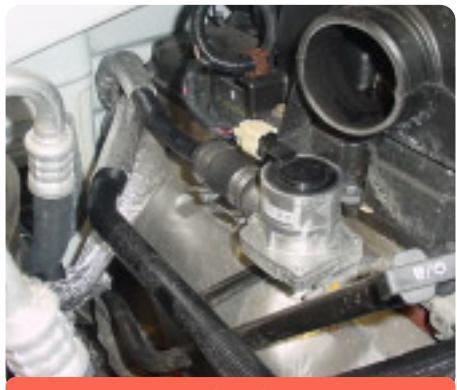
New AIR Shut-Off Valve

The electronic shut-off valve contains an integral solenoid and check valve. The valve has no removable parts and the solenoid and valve are serviced as an assembly. The current draw of the solenoid is 2.5 to 5 amps. This high current draw requires the addition of a relay to protect the control module driver. A resistance greater than 15 to 17 ohms in either the voltage supply or ground cir-

cuits of the solenoid will affect valve operation.

The shut-off valve opens reliably when commanded ON by the control module. Because the valve is electronically operated instead of by vacuum, conditions such as low manifold vacuum, high altitude or heavy acceleration have no adverse effects on the operation of the valve. The internal check valve protects caustic exhaust gases from damaging the AIR system components.

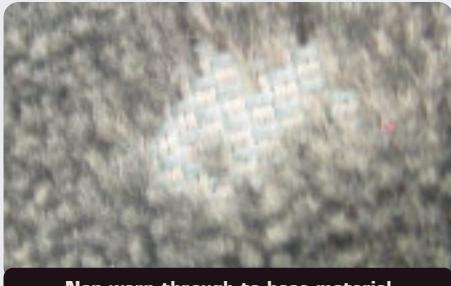
Under some circumstances, the nap may become crushed down, giving the appearance of being worn out. **TIP:** If the base material is visible, the material is worn, and this procedure is not a remedy.

Nap worn through to base material

If the base material is not visible, use a small wire brush to carefully raise the nap. Wire brushes similar to the one
