Removing Transseal Protective Film

Techline News

Service and Parts Operations

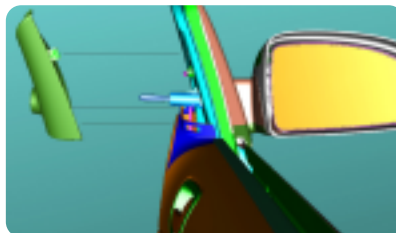
Cobalt Door Upper Front Trim Panel

On the 2005 Cobalt, the method for attaching the Side Door Upper Front Trim Panel ("shark fin") depends on the trim level.

On uplevel models with power outside rearview mirror, the extension is heat-staked to the door trim panel. There is no provision for removal. Attempting to do so will result in damage to the door trim panel.

On base models with manual outside rearview mirror, the extension is removable by pulling the trim piece straight back from the door; it is held in place by clips.

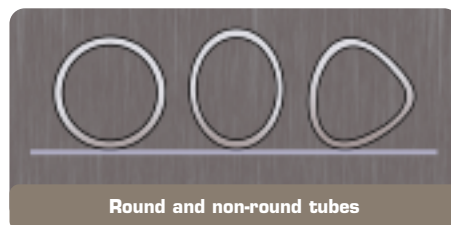
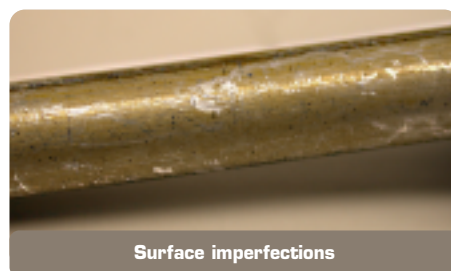
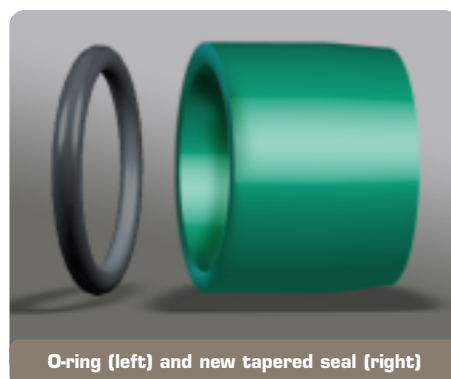
The original filter design incorporated an O-ring to seal around the A/C tube OD. Successful installation required a smooth round surface. Technicians pointed out the obvious field reality:

- Tubes are not all perfectly round
- Tube finish has surface imperfections

- Installing the filter collar twice to assure proper seating is inefficient and time-consuming.

The redesigned filter replaces the single O-ring with a robust tapered sealing sleeve. The seal provides 10 times the sealing area and greatly increases the seal's ability to overcome tube irregularities. The addition of slots on the brass ferrule permits the ferrule to seat correctly on the first installation and increases compression on the seal.
