A Monthly Publication for GM Dealership Service Professionals

Side Blind Zone Alert System

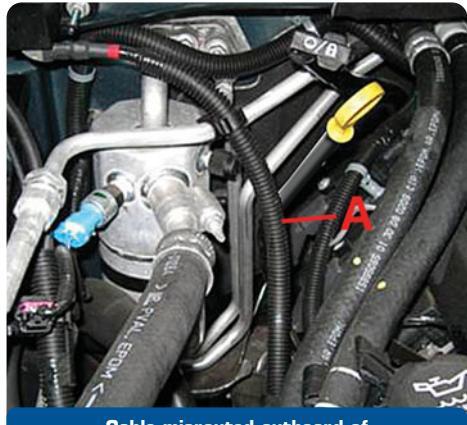
Some customers may comment on a buzz and/or rattle noise that occurs at 40-45 mph (64-72 km/h) and/or 1100-1300 rpm just before the V4 to V8 transition. The noise sounds as though it's coming from within the IP. The cause may be the generator B+ cable misrouted on the outboard side of the engine oil level indicator tube. At 1200 rpm in V4 mode (AFM), the engine oil level indicator goes into resonance and vibrates against the generator cable which produces a rattle noise in the vehicle.

Cable misrouted outboard of oil level indicator tube A Cable touching oil level indicator tube

To correct this concern, reroute the generator B+ cable on the inboard side of the engine oil level indicator. Be sure the generator cable has at least 15 mm of clearance to the engine oil level indicator tube.

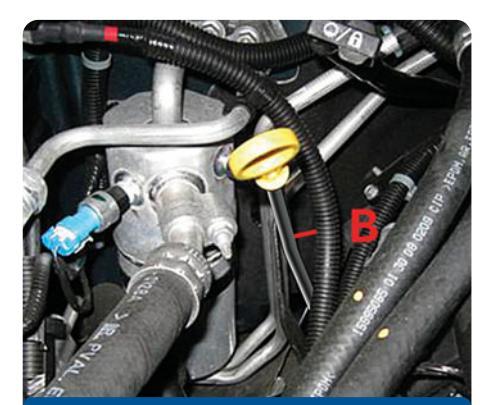
Cable correctly rerouted inboard of oil level indicator tube B 15 mm clearance between cable and oil level indicator tube
