# TECHLink

September 2003  
Volume 5, No. 9

Monthly Publication for GM Dealership Service Professionals

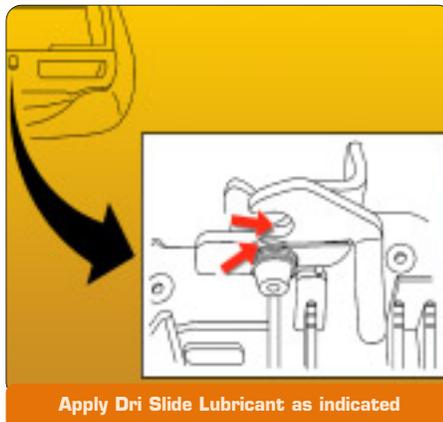
Owners of some 1999-2003 Chevrolet and GMC fullsize pickups and utilities with a center console may comment that the lid is hard to open or close. According to bulletin 02-08-49-007, this may be caused by insufficient lubrication on the latch.

Apply Dri Slide Lubricant as indicated

**TIP:** Do not replace parts in an attempt to repair this condition.

the center console latch handle button and give the top of the center console lid a sharp rap with your hand.

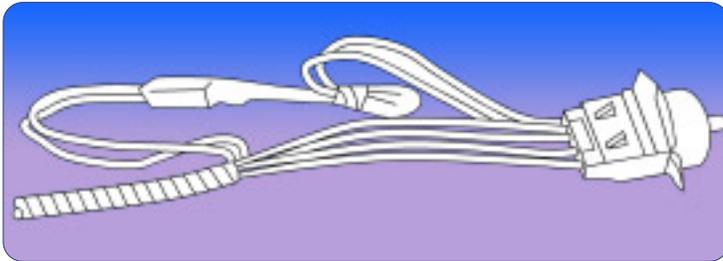
Product Safety Bulletin 03006A (May, 2003) explains that a fused jumper harness may need to be added to the electric mirror switch of certain 1997-98 trucks. This harness addresses the possibility of a short circuit in the mirror switch. See the bulletin for details.

All steps of the installation procedure must be done, and must be done in the order given.

**TIP:** To avoid damaging the fusing circuit contained in the recall harness, DO NOT connect the two-cavity connector until instructed to do so.
