2007 Saturn VUE Green Line Hybrid System

Techline News

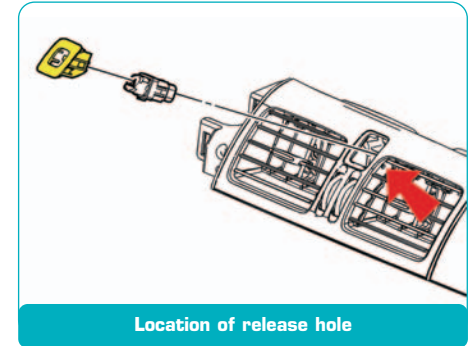
When removing the hazard warning switch from the 2006-07 Buick Lucerne, do not attempt to pry out the hazard switch bezel. Damage will occur to the HVAC outlet assembly.

Insert special tool J 42214 or similar tool into the hole in the air outlets **on each side** of the switch to release the retaining tabs. For details, refer to document 1646965 in SI.

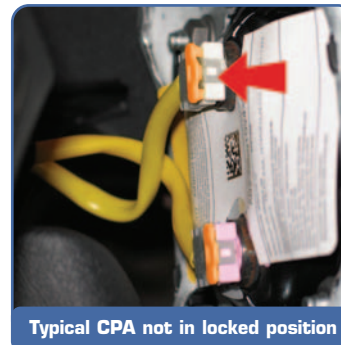
The DTCs which might be set are B0012, B0013, B0016, B0019, B0020, B0022, B0023, B0026, B0033, B0040, B0042, B0044.

Inspect for a loose, missing, or broken Connector Position Assurance (CPA) retainer. If loose, remove the connector and reinstall correctly by first pushing the connector body in completely and then pushing in the CPA completely.

If the CPA is broken, missing, or will not seat connector correctly, replace the CPA retainer with part number 54590003 (orange CPA) that is located in the SIR Repair tray of the J-38125 Terminal Repair Kit.

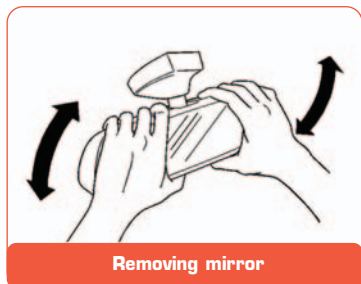
TIP: Do NOT pull rearward on the rearview mirror while removing or installing the mirror. Damage to the support or to the windshield may occur.
