## Spark Ignited Direct Injection (SIDI) Engines

GM *TechLink* is a monthly magazine for all GM retail technicians and service consultants providing timely information to help increase knowledge about GM products and improve the performance of the service department.

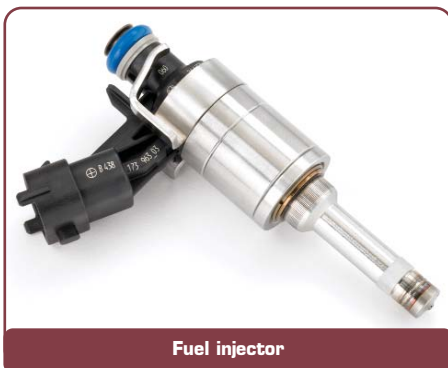
Fuel injector

Electro-magnetic **fuel injectors** are used. They mount to the cylinder head and spray fuel directly into the combustion chamber. Precision-machined holes generate a cone shaped spray pattern. The injector hold-down clamp must be replaced if removed.

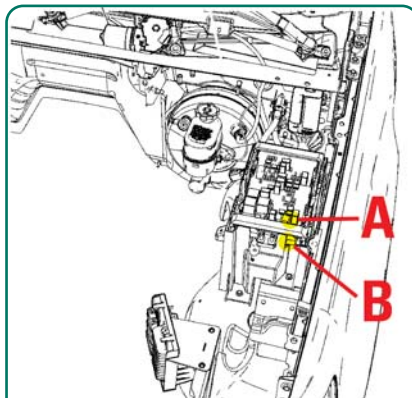
**A** – Insert a J-Case fuse with a 40 amp maximum rating into this position for stud to be powered.

**B** – Use outboard M6 stud for a fused battery feed.

For any of these powered connections to be used, Circuit Protection Guidelines must be followed to assure that the circuit gauge is selected appropriately so that it will be protected by the fuse in the case of a short circuit.

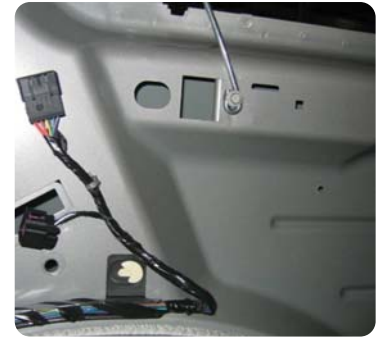
This may be caused by a loose or disconnected connector behind the right side C pillar trim. Examine the 10 pin connection that is behind the passenger's side C pillar trim (located in front of the rear HVAC case if equipped) and repair as needed.
