#### A Monthly Publication for GM Dealership Service Professionals

#### **Techline News**

#### Tech 2 Replacement – Fact or Fiction?

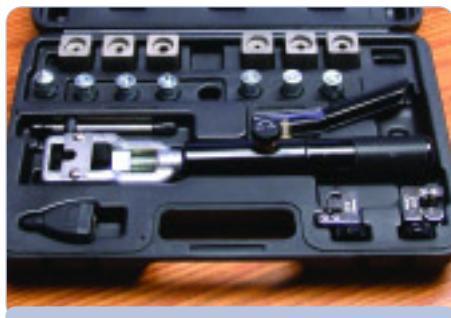
J-45505 Brake Line Flaring Kit

The Brake Pipe Flaring Set J-45505 contains all of the tools necessary to cut, strip and flare brake pipe. These tools have been made as small as practical, to permit them to be used in cramped areas on the vehicle.

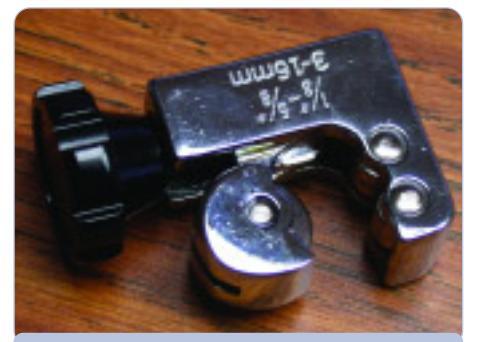
**Brake Line Cutter**

The brake pipe cutter can be adjusted to cut tubing from 1/8-inch to 5/8-inch (3 - 16 mm).

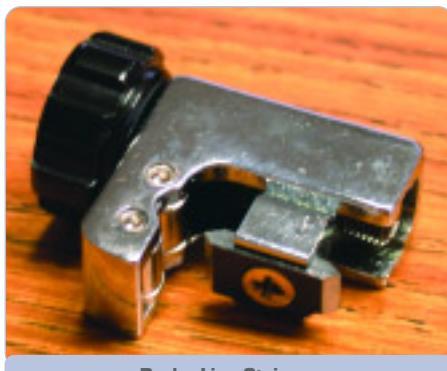
Brake Line Stripper

The stripper is equipped with two guide rollers and an adjustable stripping blade. Simply insert the pipe between the rollers until it contacts the stop. This controls the length of coating that is removed. Then snug the rollers and twist the stripper to remove the vinyl coating.

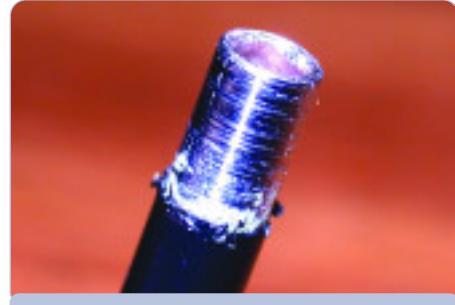
Brake line with coating stripped off

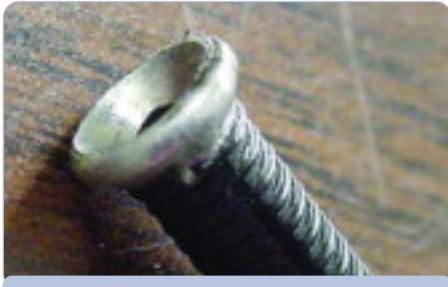
90° double inverted flare

**TIP:** Be sure to use the proper die type. Past and present GM vehicles use either single lap or double lap flares. Using the incorrect type can lead to brake system failure

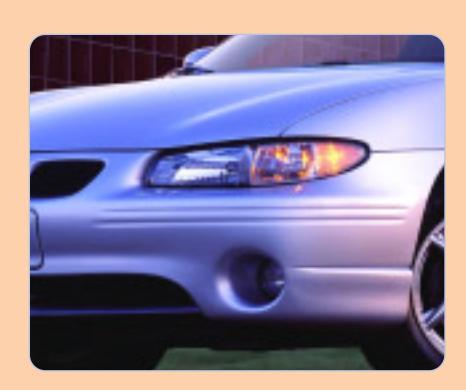
# **Blue Fog Lamps**

The 2003 Limited Edition Grand Prix has special blue fog lamps. The replacement bulb is different from current Grand Prix lamps. The replacement bulb has a wire pigtail and is available from GMSPO under AC Delco part number 11513798.

TIP: It is not necessary to replace the entire fog lamp when the lamp burns out. Replace only the bulb.

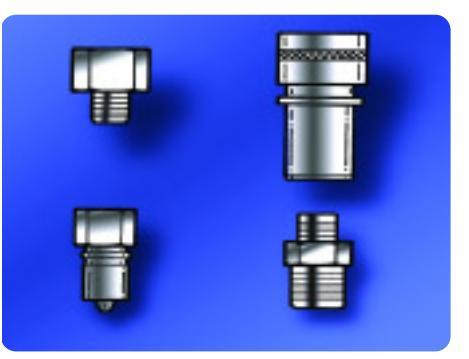
#### J-34730-40 Fuel Pressure Gauge Quick Connect Adapters

These adapters are used with the J-29658-D Fuel Pressure Gague kit and J-34730-1A Fuel Pressure Gauge and Hose Assembly to test and diagnose the supply and return fuel systems.

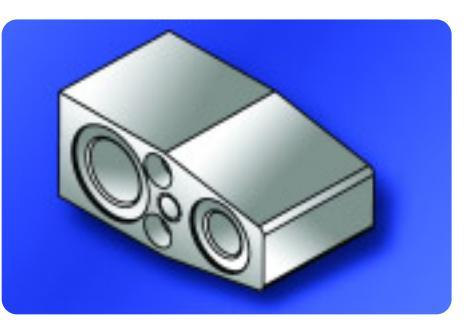
#### J-45268-115 TXV Adapter

This adapter is used to replace the TXV when doing an A/C flush with the ACR2000. The TXV must be removed to allow refrigerant to flow through the A/C system.

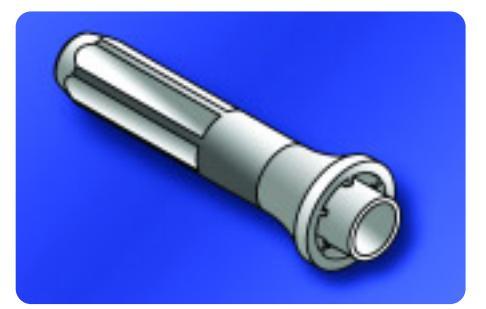
#### J-46405 Seal Installer

The axle shaft seal has been updated for improved performance. The J-36797 Seal Installer no longer fits. The new installer fits both the new seal and the first design seal.
