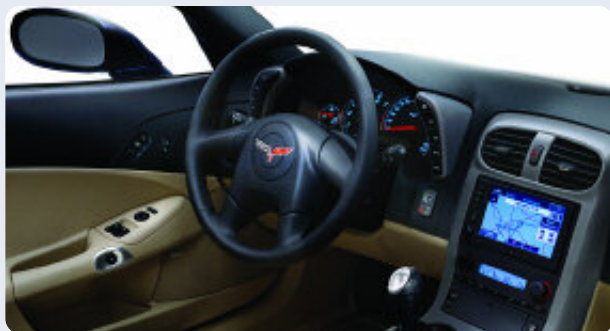
The condition may result when the gap between the insertion protection gates and the top guide plate is

larger than specification. This was caused by a warped top guide, which has been corrected in production.

Exchange the audio unit, so the top guide plate can be inspected. Do not attempt to remove a stuck CD.
