Differential Cooler	1
TIS 2 Web Update	1
Tech 2 Navigation Changes	2
Armrest Angle	3
Navigation Disc Update Program	3
EGR Valve Kit and Reprogramming	3
Remote Unlock Inoperative	3
Hood Closing	3
Water Leaks	4
Underhood Lamp	4
MAF Sensor	5
Inflatable Restraint Module Coil Noise	5
Truck Z Height Revisited	6
Rear Main Oil Seal Leak	6
Fold and Tumble Seat	6
4WD Models with Noise, Vibration	7
Camshaft Actuator System Debris	7
Code P0171 and No Performance Concerns	7
Fix It Right the First Time	8
Know How Broadcasts for May	8

TECHLink GM

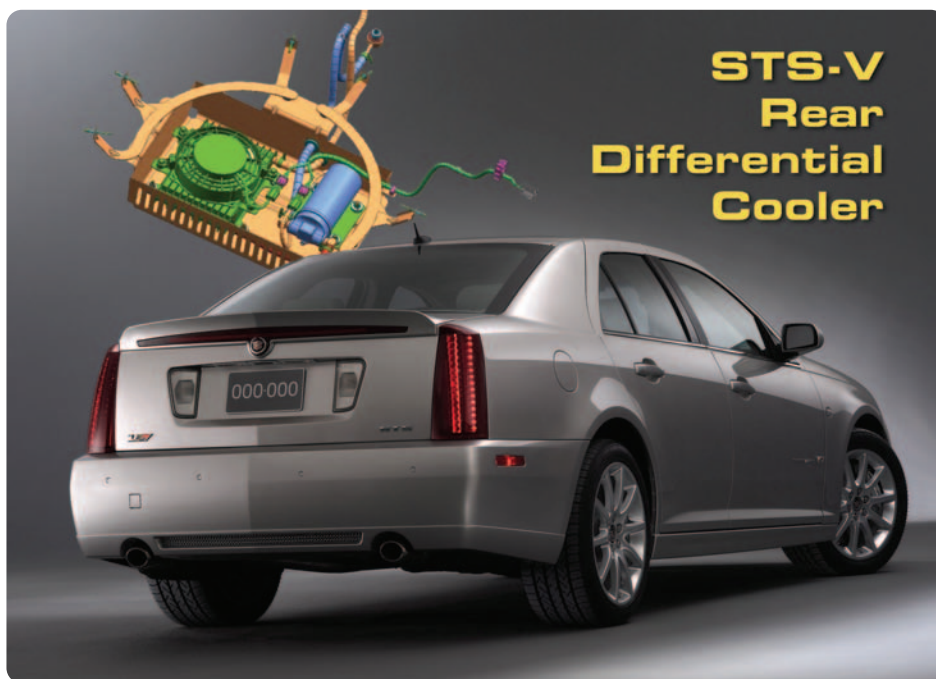
Differential Cooler

This month (April 2006) a differential cooler assembly is available for the Cadillac STS-V. The part number is 15868857.

The system is designed to reduce the operating temperature of the rear differential fluid when the STS-V is driven at extended high speed or in competitive driving. The STS-V comes with control logic to operate the system when high heat generation conditions are met. The wiring harness has provisions for the cooler, making it an easy installation. Installation time is less than 2 hours.

The differential lubricant pump and cooler assembly is located under the vehicle and is mounted to the rear storage compartment well. The cooler module assembly consists of a pump, a heat exchanger, an electric fan and assorted hoses/fittings. All components except the external lines and fittings are located in the Cooler Module.

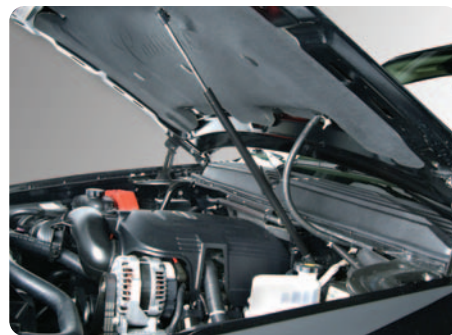
Hood Closing

This information applies to the 2007 full-size utilities, which use a center-mounted support strut (gas spring) for the hood.

Before closing the hood, be sure all the filler caps are properly installed. Then bring the hood from full open to within 6 inches (150 mm) of the closed position, pause, then push the front center of the hood with a swift, firm motion to fully close the hood.
