A Monthly Publication for GM Dealership Service Professionals

Fuse News

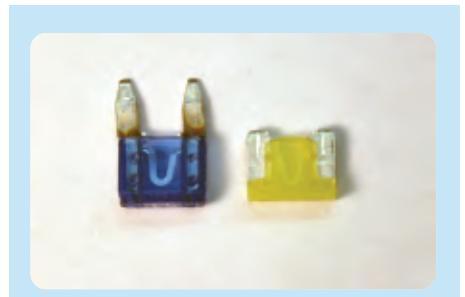
Some confusion has resulted when a technician pulls one of the new Micro fuses for the first time. Because the terminals are alongside the body of the fuse, and don't protrude as they do on Minis and Maxis, the first thought is that the terminals have broken off and remained in the BEC. As explained elsewhere, the Micros are made this way so they have a much lower height when installed. This permits using a smaller and lighter BEC.

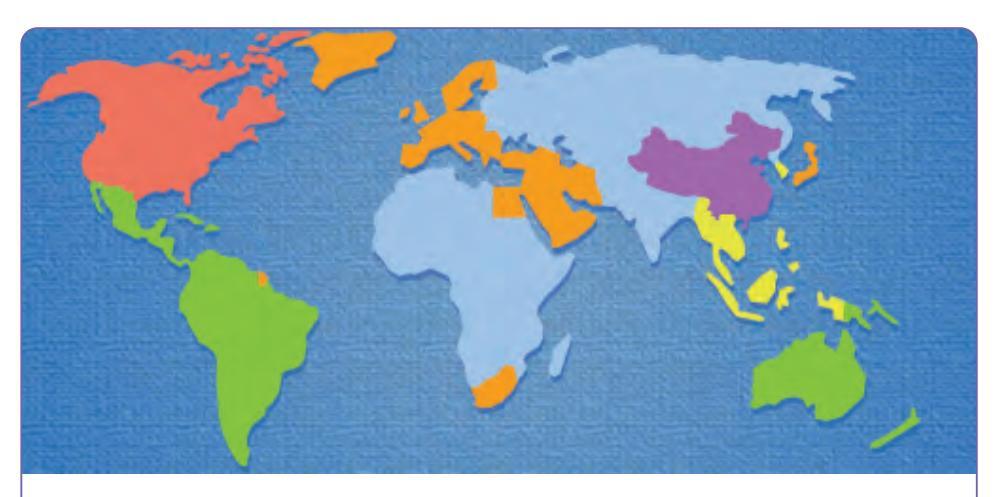
It is critical to select the correct calibration when programming a radio.

For each radio receiver, the number of times the DVD region code can be changed is limited; then the radio locks

up and cannot be programmed again. Failure to select the proper software/calibration set can lead to a loss of system functionality and cause unnecessary radio replacement.
