A Monthly Publication for GM Dealership Service Professionals

Getting the Most from Your Digital Remote Pressure Gauge

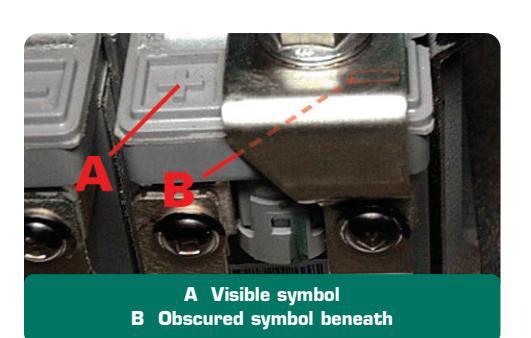
On each battery top, one symbol is visible and one symbol is obscured by the top of the bus.

IMPORTANT: The symbol that is visible on each battery DOES NOT indicate the polarity of the cable terminal adjacent to it. In fact, in each case, the symbol showing on the battery top is THE OPPOSITE of the

polarity of the cable terminal adjacent to it.

This illustration shows the locations of the + and - cable terminals and cable routings.

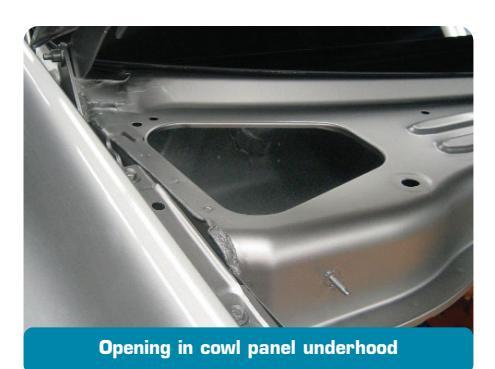
Source of water leak A Water exits through drain hose B Water reenters and drips onto **IP BEC** from sheet metal

The owner of an Acadia, Enclave or OUTLOOK may comment that the engine continues to run after the ignition is turned off, or that the engine will not

start. This may be the result of water intruding into the instrument panel (IP) BEC. Before proceeding with other diagnosis and repairs, here are some suggestions.

Water from the right front sunroof drain hose exits the vehicle. If it then re-enters the vehicle through the front of dash sheet metal, it can drip from the right side dash onto the IP BEC.
