## XM Satellite Radio is Coming

## Contents

## TECHLink

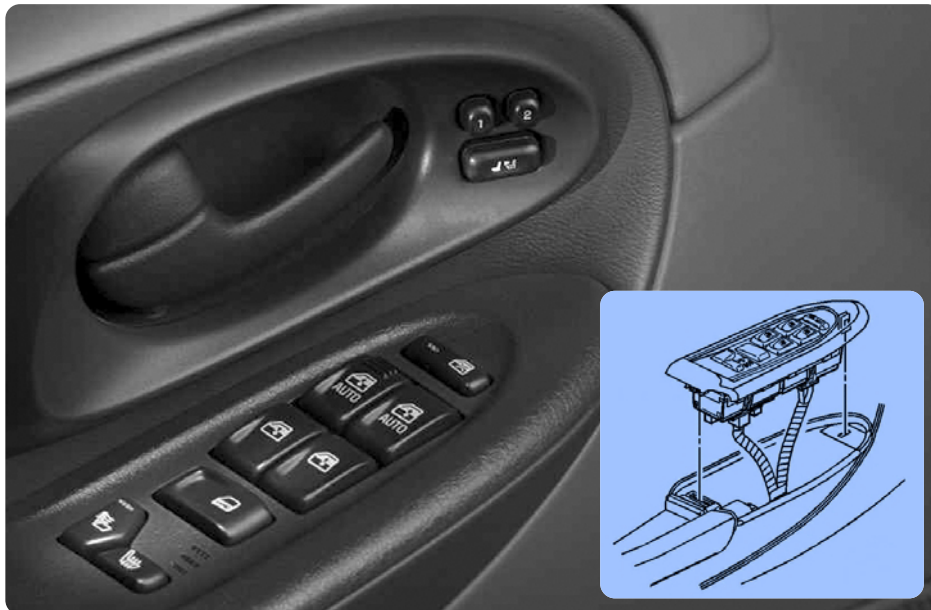
Two of the modules listed are the Driver Door Module and Passenger Door Module. While these components do contain modules that require programming after replacement, they are also the door window and lock switches. The parts catalog calls them Front Door Lock and Side Window Switches and so does the replacement procedure in the service manual and the Labor Time Guide.

So, when you replace a Front Driver or Passenger Door Lock and Side Window Switch on these trucks, remember that programming is required.

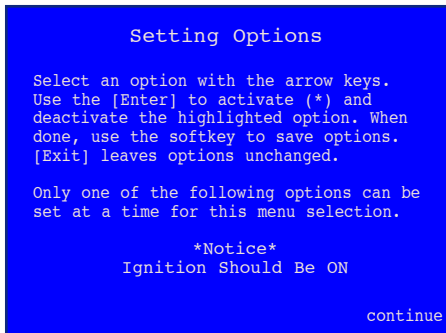
Owners of 2001-2002 models of these vehicles may comment that the premium radio system (with amplifier UQ3 option) produces too much bass in the auto tone modes, but is OK in the manual mode.

- Select Radio
- Select Special Functions
- Select Bass Frequency Response

**The Tech 2 will display:**

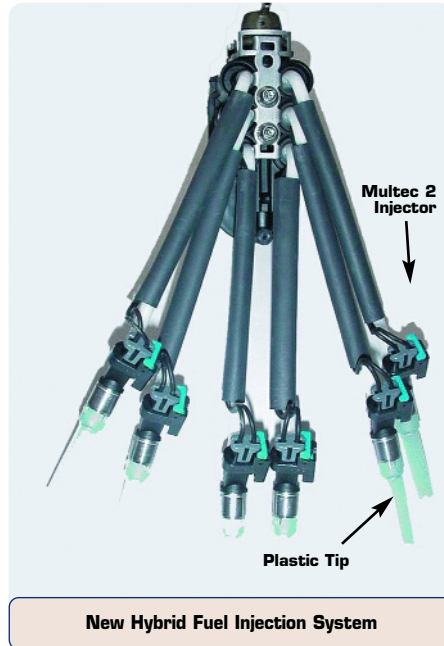
When you remove the engine's upper intake plenum, you will notice the differences. The new design uses the fuel meter body from the SCPI injection system. However, the SCPI fuel injector and poppet nozzle have been replaced with the state of

the art Multec 2 fuel injector. A new bracket is used to retain the fuel meter body to the intake manifold.

You will also notice that a white plastic tip is added to the end of the fuel tube. This is a retainer to hold the tip of the fuel tube securely in the manifold and pointed toward the intake port. The tip is quite robust and should hold the injector in place for the life of the vehicle.

Service of the unit involves some careful consideration. At this time, no cleaning has been recommended for the new system equipped with Multec 2 injectors.

**IMPORTANT:** Service bulletin 00-06-04-003 was written to clean and unstick poppets on SCPI systems. Do NOT use procedures in this bulletin on Multi-port Flexible Injection systems or permanent damage to the unit may result.
