Electrical Terminal Update

Tracker Dome Lamp Conditions

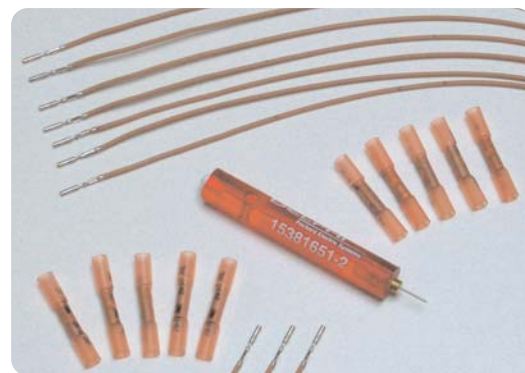
Electrical terminals continue to become smaller. The new Delphi Packard Micro 64 connector system is the next evolution in densely packed electrical connections. Bulletin 01-08-45-006 contains information about repairing circuits equipped with the new Micro 64 terminal. It's used in the Powertrain Control Module connectors on 2002 Chevrolet Cavalier, Pontiac Sunfire and Grand Am, and Oldsmobile Alero, as well as the new XM radio on 2002 Cadillac models.

You can obtain a Micro 64 terminal package, J-38125-64SPL, from Kent-Moore. It includes a terminal pick, ten pre-terminated leads, and ten wire splices, which can be installed using the existing crimper from your Terminal Repair kit.

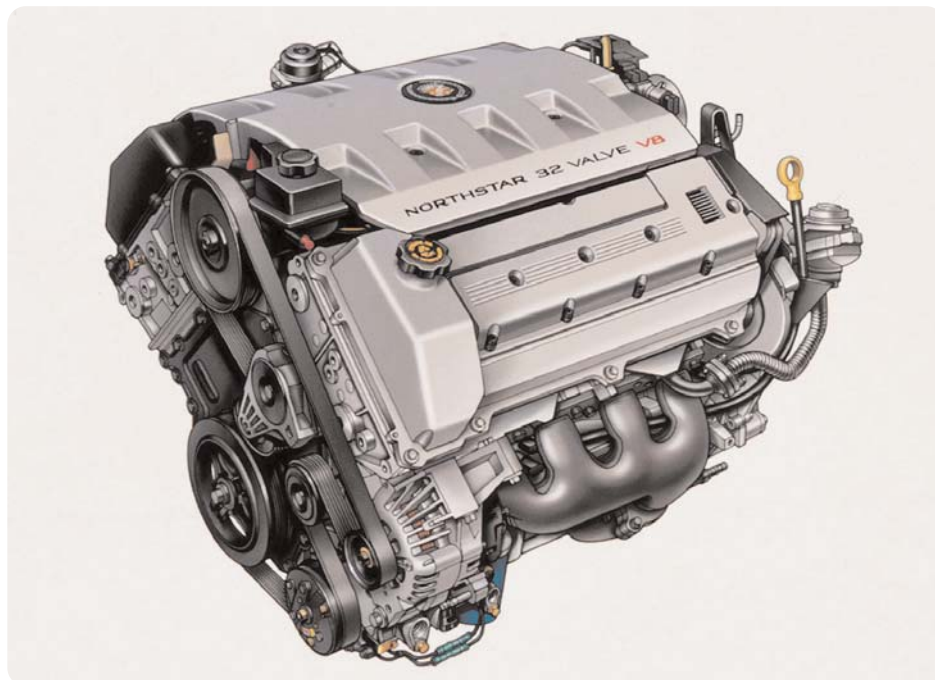
One of the major reasons for oil consumption is combustion deposits that build up on the piston rings and cause them to stick in the piston. Stuck rings cannot effectively wipe the oil off the cylinder walls, and the oil will burn in the combustion process.

The multi-step procedure is detailed in the upcoming bulletin. Briefly, you will use the components in the J-45076 tool kit to install Piston and Ring Cleaner 12378549 (88901334 in Canada) through the spark plug holes into the warm cylinders. After a 2-hour soak, you will vacuum the cleaner from the engine and change the engine oil. Then you will apply Induction Cleaner 12378552 (88901336 in Canada) to the EGR and throttle body using components of the J-45076 tool kit.

Finally, you will road test the vehicle for 20 minutes, then change the engine oil again, replace the oil filter and reset the oil life system.

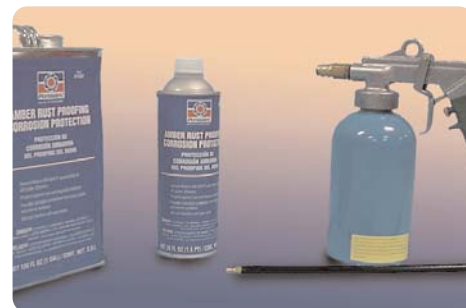
After a collision, some vehicle components, such as rocker boxes or frame rails, may need to be repaired. The anti-corrosion materials on these components may need to be replaced.

A specially designed gun and wand must be used to perform a quality interior repair. A kit is available through GM Dealer Equipment at 1-800-GM-TOOLS (1-800-468-6657, press 2 for supplies). For technical information, call 187PERMATEX (1-877-376-2839).

TIP: The Permatex Amber material is available from GMSPO, US P/N 12378571 and Canada P/N 88901677
