## Generator Operation and Troubleshooting

GM TechLink is a monthly magazine for all GM retail technicians and service consultants providing timely information to help increase knowledge about GM products and improve the performance of the service department. This magazine is a companion to the GM Edge publication.

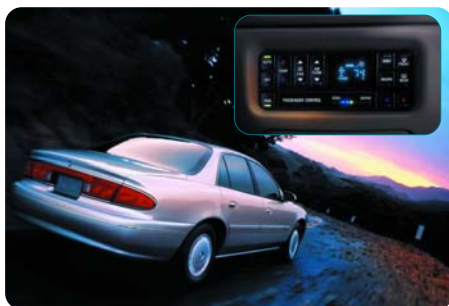
Some customers may comment that the AUTO indicator turns off under certain conditions.

1. When the temperature selector is run to the extreme in either direction (60°F/16°C or 95°F/35°C), the HVAC system will cease regulating the temperature. Instead, it outputs full cold or full hot. This defeats the AUTO function, so the indicator turns off.
2. Manually selecting a fan speed by pressing the + or - button will defeat the AUTO function, so the indicator turns off.
3. Similarly, manually selecting an air distribution path (just IP, just floor, etc.) will defeat the AUTO function, so the indicator turns off.

In all three of these cases, it is normal for the indicator to turn off, and no repair or component replacement is necessary.
