## Techline News

### Comparison of Multec 1 and Multec 2 Injectors

## Transmission Shift Conditions

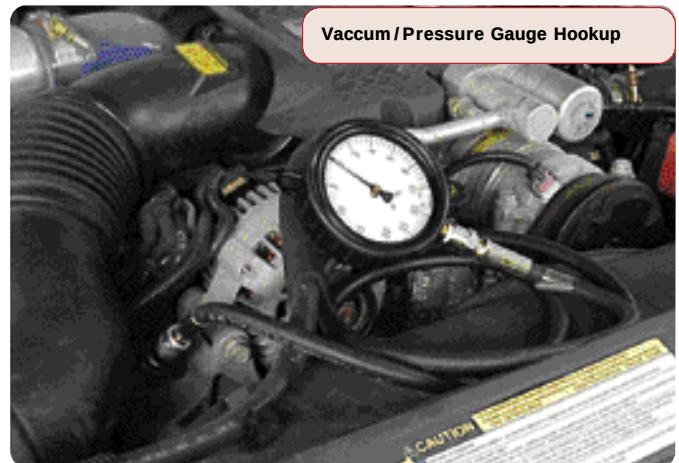
The vacuum/pressure gauge is also useful when diagnosing the Duramax 6.6L diesel. In the case of a complaint of "starts, runs, then dies," or if the vehicle will not start after sitting for a period of 30 minutes or longer, hook up the vacuum/pressure gauge to the schraeder valve on the right front valve cover to

determine if air intrusion into the fuel system is the root cause of the complaint. With the vacuum/pressure gage hooked up, prime the fuel manager until 10 psi is reached. If pressure does not reach 10 psi after twenty or so pumps, air intrusion is the cause. Refer to the fuel system diagnostic in the manual.

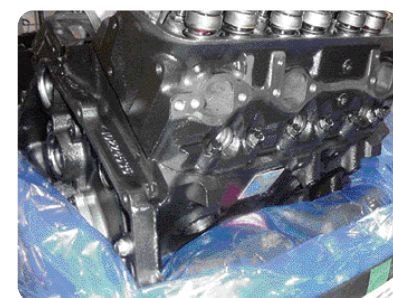
Bulletin 00-06-01-019 has been released to help identify and resolve oil consumption concerns of the 4.3L remanufactured engines. To aid in the process of continuous improvement for this engine series, you are asked to provide the Serial number: 8 digit number and the engine build date sequence number information on the Repair Order in the event you need to replace a 4.3L GM Goodwrench engine.

This information can be read from the engine ID tag.
