## Electronically Controlled Viscous Cooling Fan

### Techline News

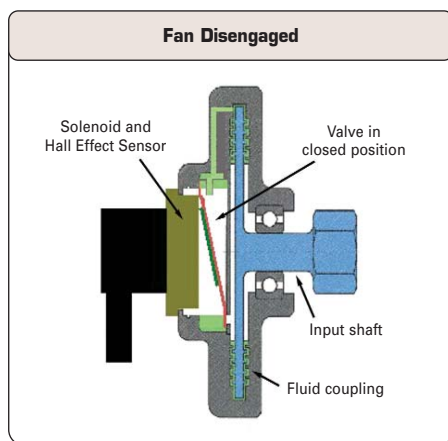
### Review of Conventional Thermostatic Fan Clutch

The conventional thermostatic clutch is a fluid coupling, belt-driven by the engine. The amount of fluid in the coupling is controlled by a bimetallic coil spring attached to a valve. More fluid is admitted into the coupling at higher temperatures, causing the fan rotation to increase. At lower temperatures, the spring closes the valve, decreasing fluid in the coupling, and the fan rotation decreases.

Fluid is pumped from a reservoir in the fan clutch into the coupling by the action of the fan shaft.

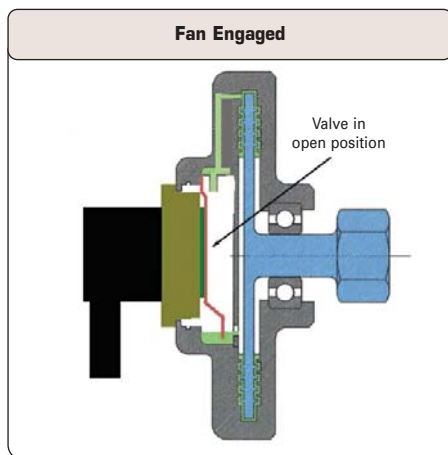
### EV Fan Operation

The EV fan clutch also operates by controlling the amount of fluid admitted into the coupling. But instead of a bimetallic spring, the valve is operated by an electrical solenoid.

The solenoid is controlled by a solid-state device, operated by a pulse-width-modulated (PWM) signal from the PCM. As the commanded state of the fan clutch increases, so does the ON time of the relay.
