# New Levels of Precision in Wheel Alignment

### Techline News

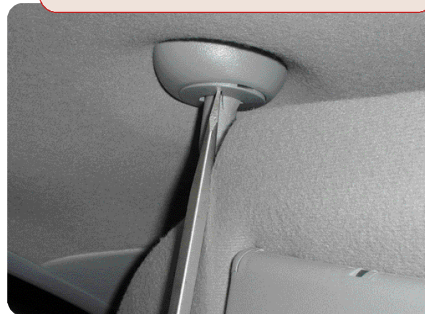
**Screwdriver in slot.**

If you use the incorrect removal procedure or the incorrect tools, you will break the visor or cause cosmetic damage to the plastic parts.

bezel on the headliner. Push the visor to the headliner while maintaining the screwdriver in the correct position and continue rotating the visor toward the side window.

Pull the retainer from the bezel and disconnect the electrical wires if equipped with lighted visor vanity mirrors.

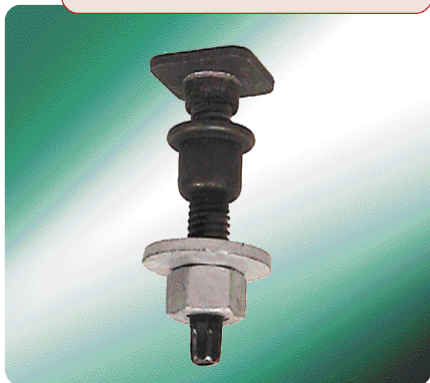
Steering column fastener

But when you loosen the steering column fasteners, DO NOT simply loosen the retaining nuts. In many cases, the nut and stud come out as a unit, leaving the square nut stranded in the depression on the top side of the mag

beam. Then, when you attempt to install the stud, the square nut will be pushed out of position. It may then be necessary to loosen and move the instrument panel to gain access to the square nuts.

Here's the proper method for loosening the nuts. First, install a 13 mm crowfoot wrench to the nut. Then, install a number 7 inverted Torx socket to the bottom of the stud. Use the Torx socket to hold the stud while you loosen the nut with the crowfoot wrench. This prevents the stud from unscrewing from the square nut. Now, when you lower the steering column, the stud and square nut remain in position on the magnesium beam.

When you install the steering column, torque the retaining nuts to 27 N.m (20 lb ft).
