## Battery Charging Tips

## Techline News

GM TechLink is a monthly magazine for all GM retail technicians and service consultants providing timely information to help increase knowledge about GM products and improve the performance of the service department. This magazine is a companion to the GM Edge publication.

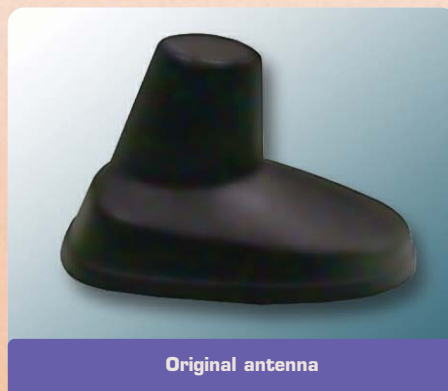
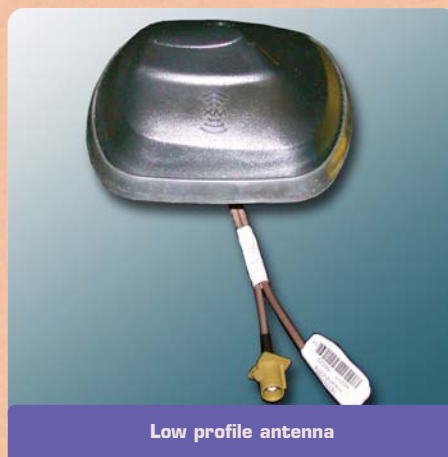
The digital antenna is positioned on the roof in various locations, depending on

the model. The antenna was tested and validated in its current location.

**TIP:** Do not attempt to relocate the antenna; a degradation in reception quality will occur.
