What Happens When a Radio is Swapped?

GM TechLink is a monthly magazine for all GM retail technicians and service consultants providing timely information to help increase knowledge about GM products and improve the performance of the service department. This magazine is a companion to the GM Edge publication.

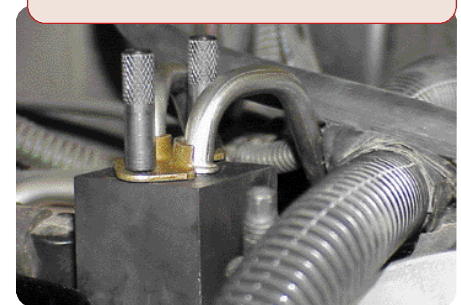
J-44466-11 Fuel Line Recirculating Block

Bulletin numbers 99-06-01-022 and 00-06-04-003 address cleaning of poppet nozzles on CPI and SCPI units. On SCPI units, the poppets can stick shut occasionally and cause driveability concerns. To determine if the poppet is stuck shut, follow the Strategy Based Diagnostic procedures in the bulletin or service manual.

Using recirculating blocks J-44466-11 and 12, the fuel system is separated into

two loops to allow cleaning and unstick at the fuel meter body. And the cleaning agent is not permitted to enter the vehicle's fuel tank, which could cause damage to the fuel pump check ball. Separating the system into two loops also eliminates the need to disable the fuel pump while running the vehicle during the cleaning operation.

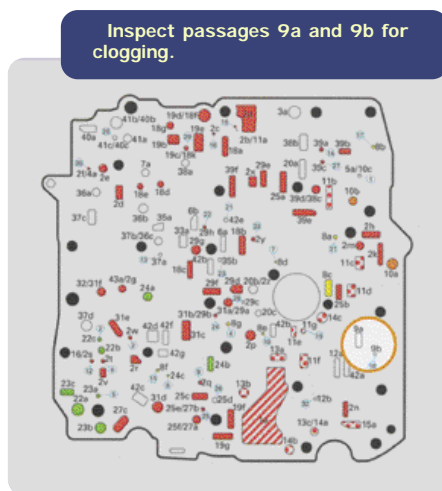
Generally speaking, the diagnostics in the service manual will lead you down the correct path if the code can be reproduced. The one notable exception is that passages 9a or 9b in the spacer plate may clog, setting a code P0741 (this will not set P0742). If normal diagnostics fail to correct a P0741, inspect these passages.

Drive the vehicle fairly hard in all gear

ranges, including manual 1, 2 and 3 to exercise the valve body. Raise the line pressure using the Tech 2. If the code does not return, it is likely the sediment causing the concern has been exhausted from the valve body and it is safe to return the vehicle to the customer.
