## Terminal Repair Kit Update

## Techline News

GM TechLink is a monthly magazine for all GM retail technicians and service consultants providing timely information to help increase knowledge about GM products and improve the performance of the service department. This magazine is a companion to the GM Edge publication.

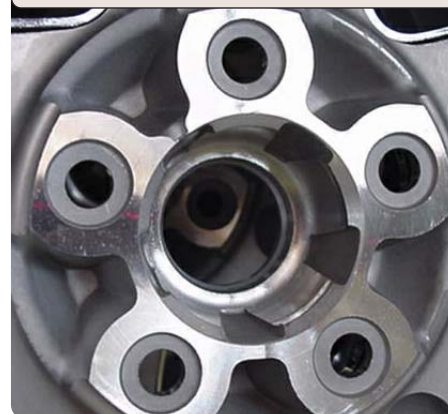
**New flat face wheel**

assembly (knuckle, hub, rotor, wheel assembly). This design also includes a new finish coating on the bearing studs and wheel lug nuts.

Important – the 2003 model year aluminum wheels cannot be used to back-service past model vehicles (2002, 2001 etc.). Part number changes and labeling have occurred for 2003 model year aluminum wheels, bearing studs and lug nuts.

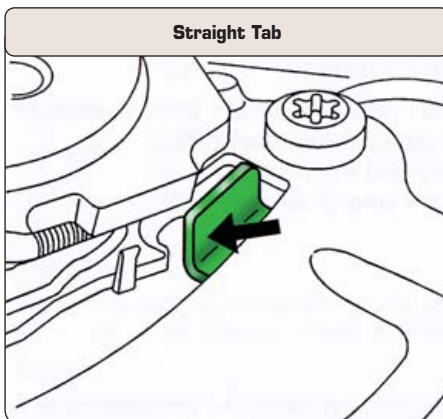
Owners of some 2002 Buick Century and Regal, Chevrolet Impala and Monte Carlo, Oldsmobile Intrigue, or Pontiac Grand Prix may comment that the windshield wipers park in the vertical (outwipe) position.

This may be caused by a bent park tab on the windshield wiper motor bracket.

If the tab is bent, you will need to install a new wiper motor crank arm 12494832 and motor bracket service kit 88958149 (88958260 in Canada). Instructions are included in bulletin 02-08-43-002.
