Allison LCT 1000 Transmission

Contents

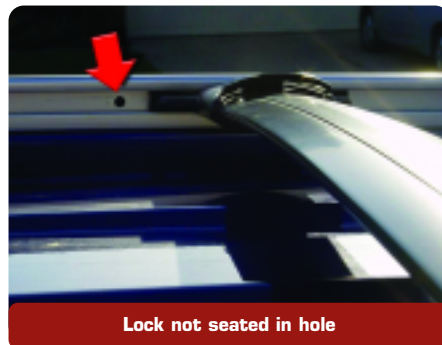
On the 2005 Equinox, incorrect diagnosis of noise and/or functionality of the luggage carrier may result if the cross-bars are not correctly locked in one of the four locking positions (holes). If the cross-bars are outside of the locking positions, the cross-bar locking levers will not completely engage and the cross-bars may rattle.
