## Articulating Running Boards

GM TechLink is a monthly magazine for all GM retail technicians and service consultants providing timely information to help increase knowledge about GM products and improve the performance of the service department.

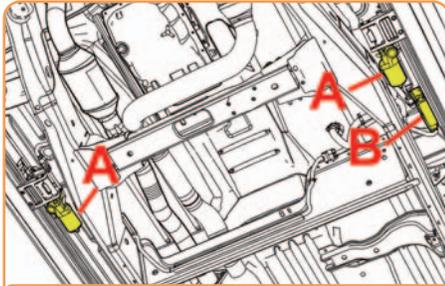
**Component locations**  
A Motor B Control module

**Motor Replacement** — Follow the SI procedure when installing a replacement motor, to ensure that the flat on the motor and the step wedge are properly aligned, to avoid unwanted noise.

**Control Module Replacement** — Although the control module is reprogrammable, replacement modules will be pre-programmed and ready for use once a new module initial setup for Assist Step Controller in the Tech 2 is completed to clear the MEC and then the Module Unlock Procedure is executed.

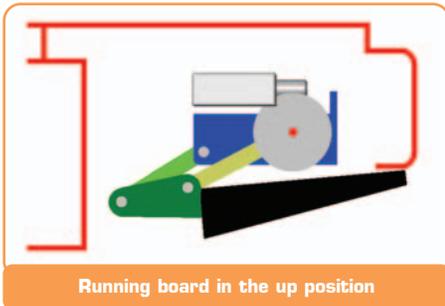
**Running board in the up position**

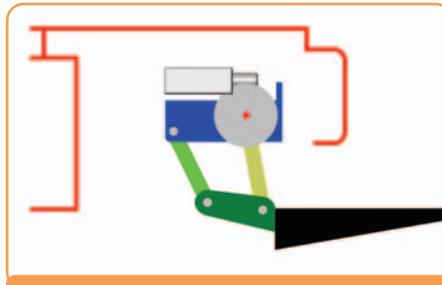
**Running board in the down position**

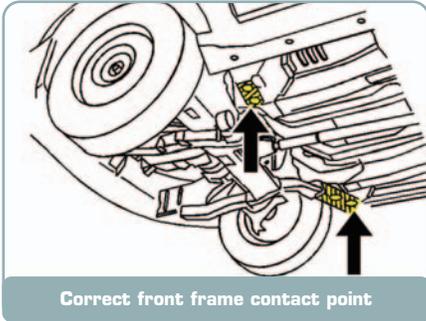
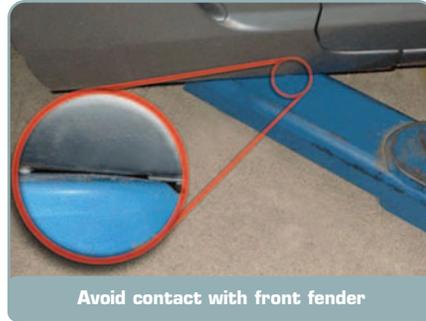
## Lifting the Saturn Sky

When lifting the Saturn Sky, it is very important to place the lifting pads in the correct position under the vehicle to avoid damage.

**TIP:** The correct procedures for the 2007 Saturn Sky are explained in Lifting and Jacking the Vehicle in SI.
