A Monthly Publication for GM Dealership Service Professionals

# **Fuel Economy Facts and Myths**

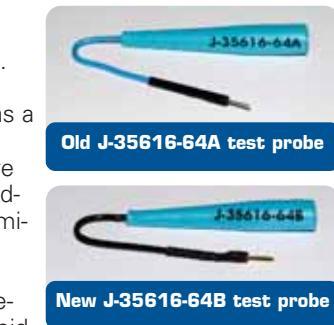
All of these connection systems use the J-35616-64B test probe. There has

been an update to this probe. The latest version has a black wire and a more robust goldplated terminal probe. Use the probe carefully to avoid

damage to the terminal.

*TIP:* The earlier probe has a white or blue wire and a tin terminal probe.

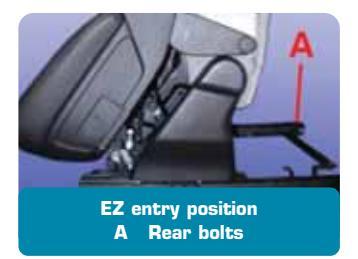
If instead the seatback folds to the flat stow position when the EZ entry handle is operated, it is necessary to remove the seat from the vehicle for

repair. Before this can happen, the seat must be manipulated to the EZ entry position for access to the rear foot mount bolts.

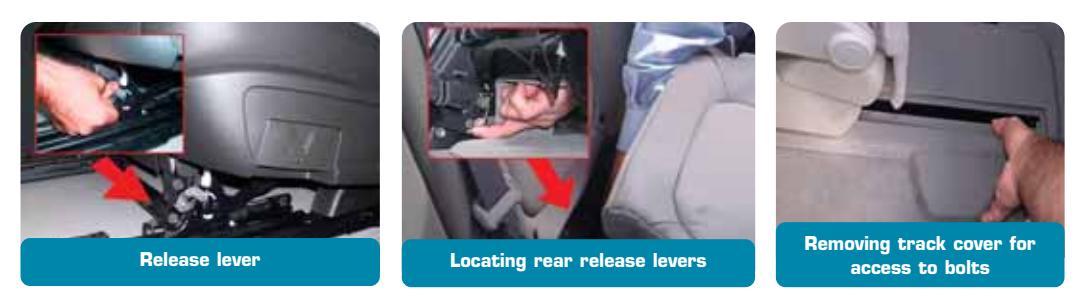
Carefully push down on the release levers on the front carriages. Release both inboard and outboard sides.

TIP: The seat cushion will slide forward and the rear will tilt up when both carriage latches are released.

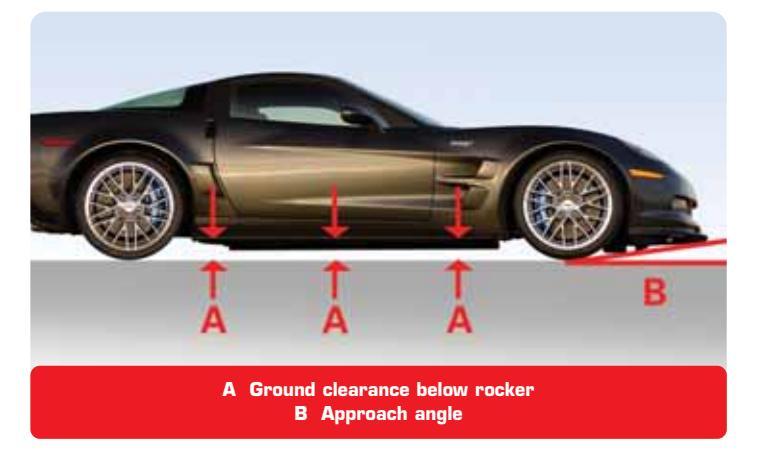
#### **ZR1** Dimensions

Refer to the illustration. The ground clearances under the front valance and rocker panel moldings are very low. And due to the front overhang, the approach angle is shallow.

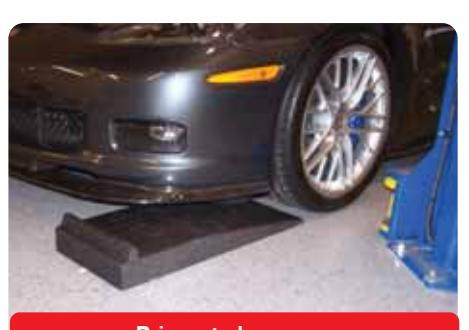
**Drive onto low ramps**

It may be necessary to drive all four of the ZR1's tires onto low ramps to allow the lift arms to fit under the vehicle, and provide the necessary clearance for the rocker moldings.

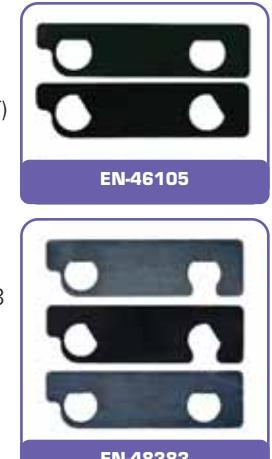
During the 2007 model year, 7.7 mm stacked-plate inverted tooth (IT) timing chains for secondary camshaft drives were phased in on all vehicles. The IT chains require EN-48383 for correct camshaft positioning because of a different camshaft angle requirement.
