Testing Fuel Injectors -- Misfires

Techline News

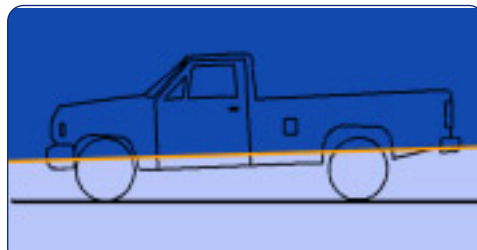
Positive Frame Angle Higher in the Rear

Wheel alignment machines measure "true" caster, which is relative to the ground. Factory specifications for caster are measured relative to the vehicle's frame. The weight of the vehicle's contents (fuel, cargo, caps, etc.) may cause the vehicle's frame to tilt relative to the ground. This tilt can affect the "true" caster measurement.

Follow procedures in SI to make the necessary adjustments to the vehicle's caster.

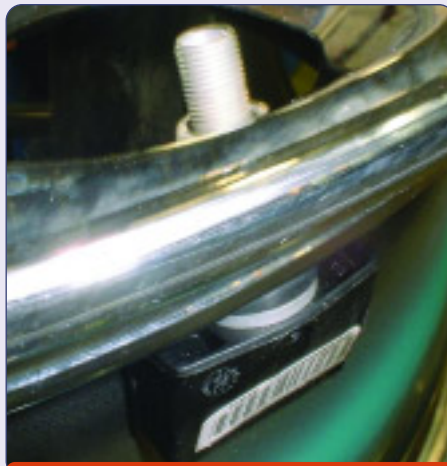
Tire Pressure Monitor Sensor

well of the rim. It's important to be careful when using a tire mounting machine. The sensor could be damaged in two ways: either by direct contact with the machinery or by the bead of the tire as it is forced over the rim.
