Brake Service Part 1 – Background, Measuring, and Cleaning

Earlier this year, bulletin 00-05-22-002D was released for the purpose of updating and centralizing all of GM's standard brake service procedures and policy guidelines for brake rotor and brake pad service and wear. If you haven't already done so, refer to this bulletin before performing your next GM brake service.

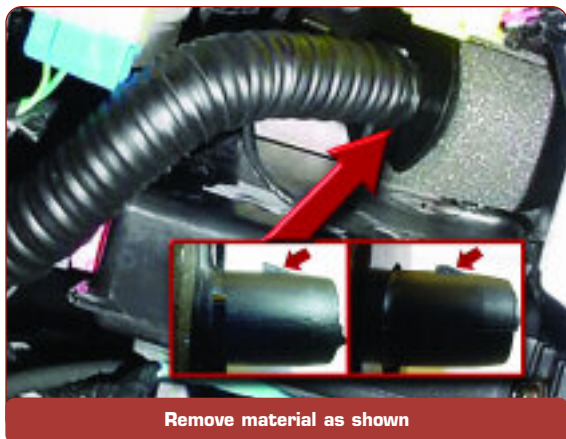
In some cases, the aspirator hose may fall off the aspirator due to the size of the hose and the aspirator tube. If you should encounter such a condition, remove 0.5mm of material from the locking tab on the aspirator to allow a tighter fit. If the aspirator hose is connected, the blower module will need to be reprogrammed.
