TECHLink

GM
December 2005
Volume 7, No. 12

A Monthly Publication for GM Dealership Service Professionals

Fuel Pump Modular Reservoir Assembly

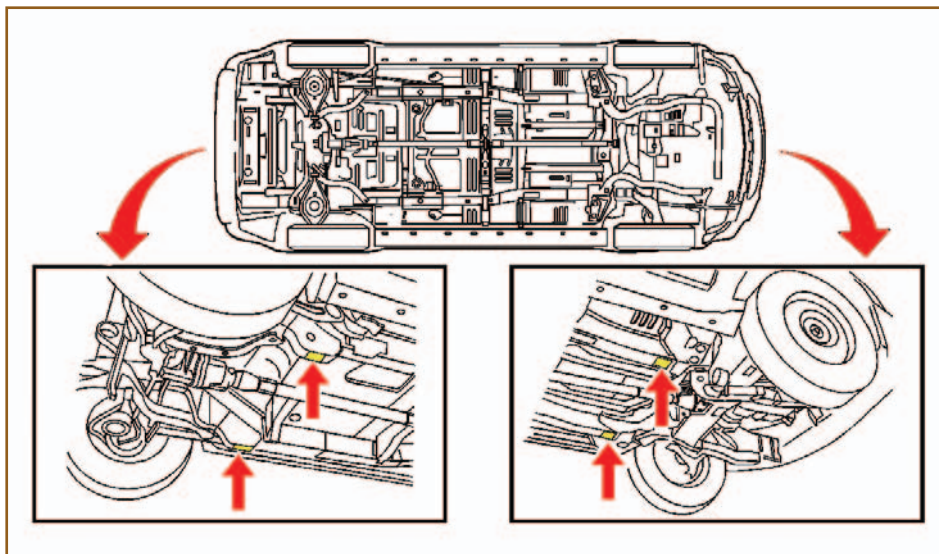
Revised Lifting and Jacking Procedure

Bulletin 05-00-89-027 contains important information on how to lift or jack the 2005-06 Equinox and Torrent.

The lift or jack pads must be located inboard from the pinchweld flanges, as specified in the bulletin, to avoid damage to the pinchweld flanges.

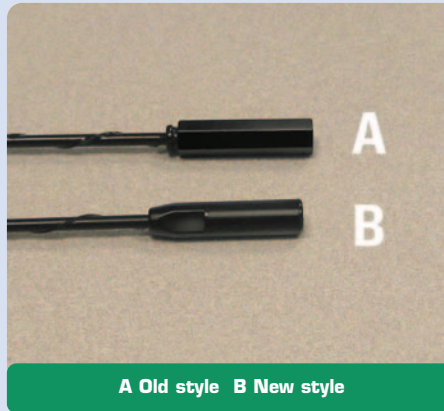
Fixed Mast Antenna

A new AM/FM fixed mast antenna is being used on 2006 full size trucks and utilities, and the TrailBlazer/Envoy. The new antenna features a 7mm stud on the antenna base, in place of the 6mm stud of the previous design.

A new antenna mast is required to mate with the larger stud. This mast can be identified by two flats on the mast; the older one had a hex (six-sided) design.

TIP: The new mast will not thread onto the base by hand. There is an interference fit between the threads of the new base and mast, which requires more force to tighten the mast to the base.

TIP: The mast no longer comes with a plastic wrench. Use hand tools to install.
