Cruise Control with Electronic Throttle Control (ETC)

Contents

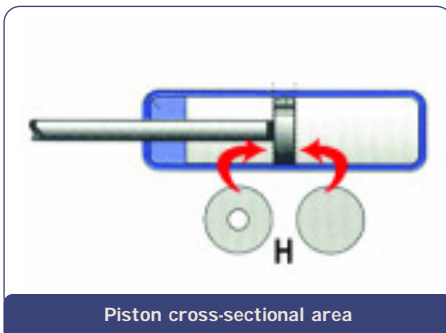
Piston cross-sectional area

When the temperature drops (cold weather), so does the gas spring's internal pressure. Under these conditions, the liftgate may not auto-rise due to the reduced assistance in opening, although it will still hold the liftgate open. And it may offer reduced resistance when the liftgate is closed.

TIP: All of these characteristics are normal and a gas spring should not be replaced if the liftgate performs as described. Replacing a normal spring (that is cold) with a new spring (that is warm) will appear to correct the "problem," but it will return as soon as the replacement springs are allowed to become cold.
