**Vac-n-Fill**  
GE-47716  
Coolant  
Refill System

## Techline News

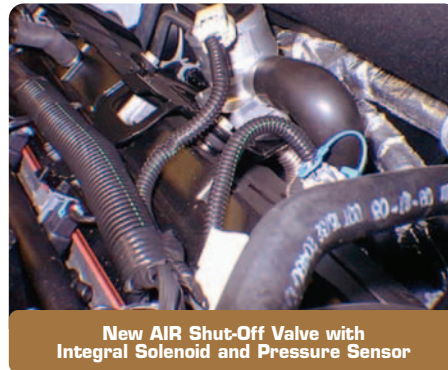
## The New Electronic Shut-Off Valve

The electronic control shut-off valve (also known as the AIR control solenoid valve/pressure sensor assembly or check valve assembly) contains:

- A pressure sensor, for monitoring airflow pressure
- A control valve that allows pressurized air from the pump to flow to the exhaust manifold
- An electrical solenoid that operates the control valve
- A check valve that keeps exhaust gases from damaging the assembly and the rest of the system

The valve has no removable parts. The solenoid, check valve, and pressure sensor are serviced as an assembly.

- A New 5-pin connector
- B Electronic solenoid
- C Pressure sensor
- D Inlet
- E Outlet to exhaust manifold
